**SUCCESSFUL REMEDIATION OF GASOLINE SPILLS
ON LONG ISLAND BY APPLICATION OF A COMBINATION
OF TECHNOLOGIES — TWO CASE STUDIES**

Ravi K. Korlipara, Ph.D., P.E.
Korlipara Engineering
315 Walt Whitman Road, Suite 316
Huntington Station, NY 11746

Mostafa El Sehamy, P.G., C.G.W.P.
Fenley & Nicol Environmental, Inc.
445 Brook Avenue
Deer Park, NY 11729

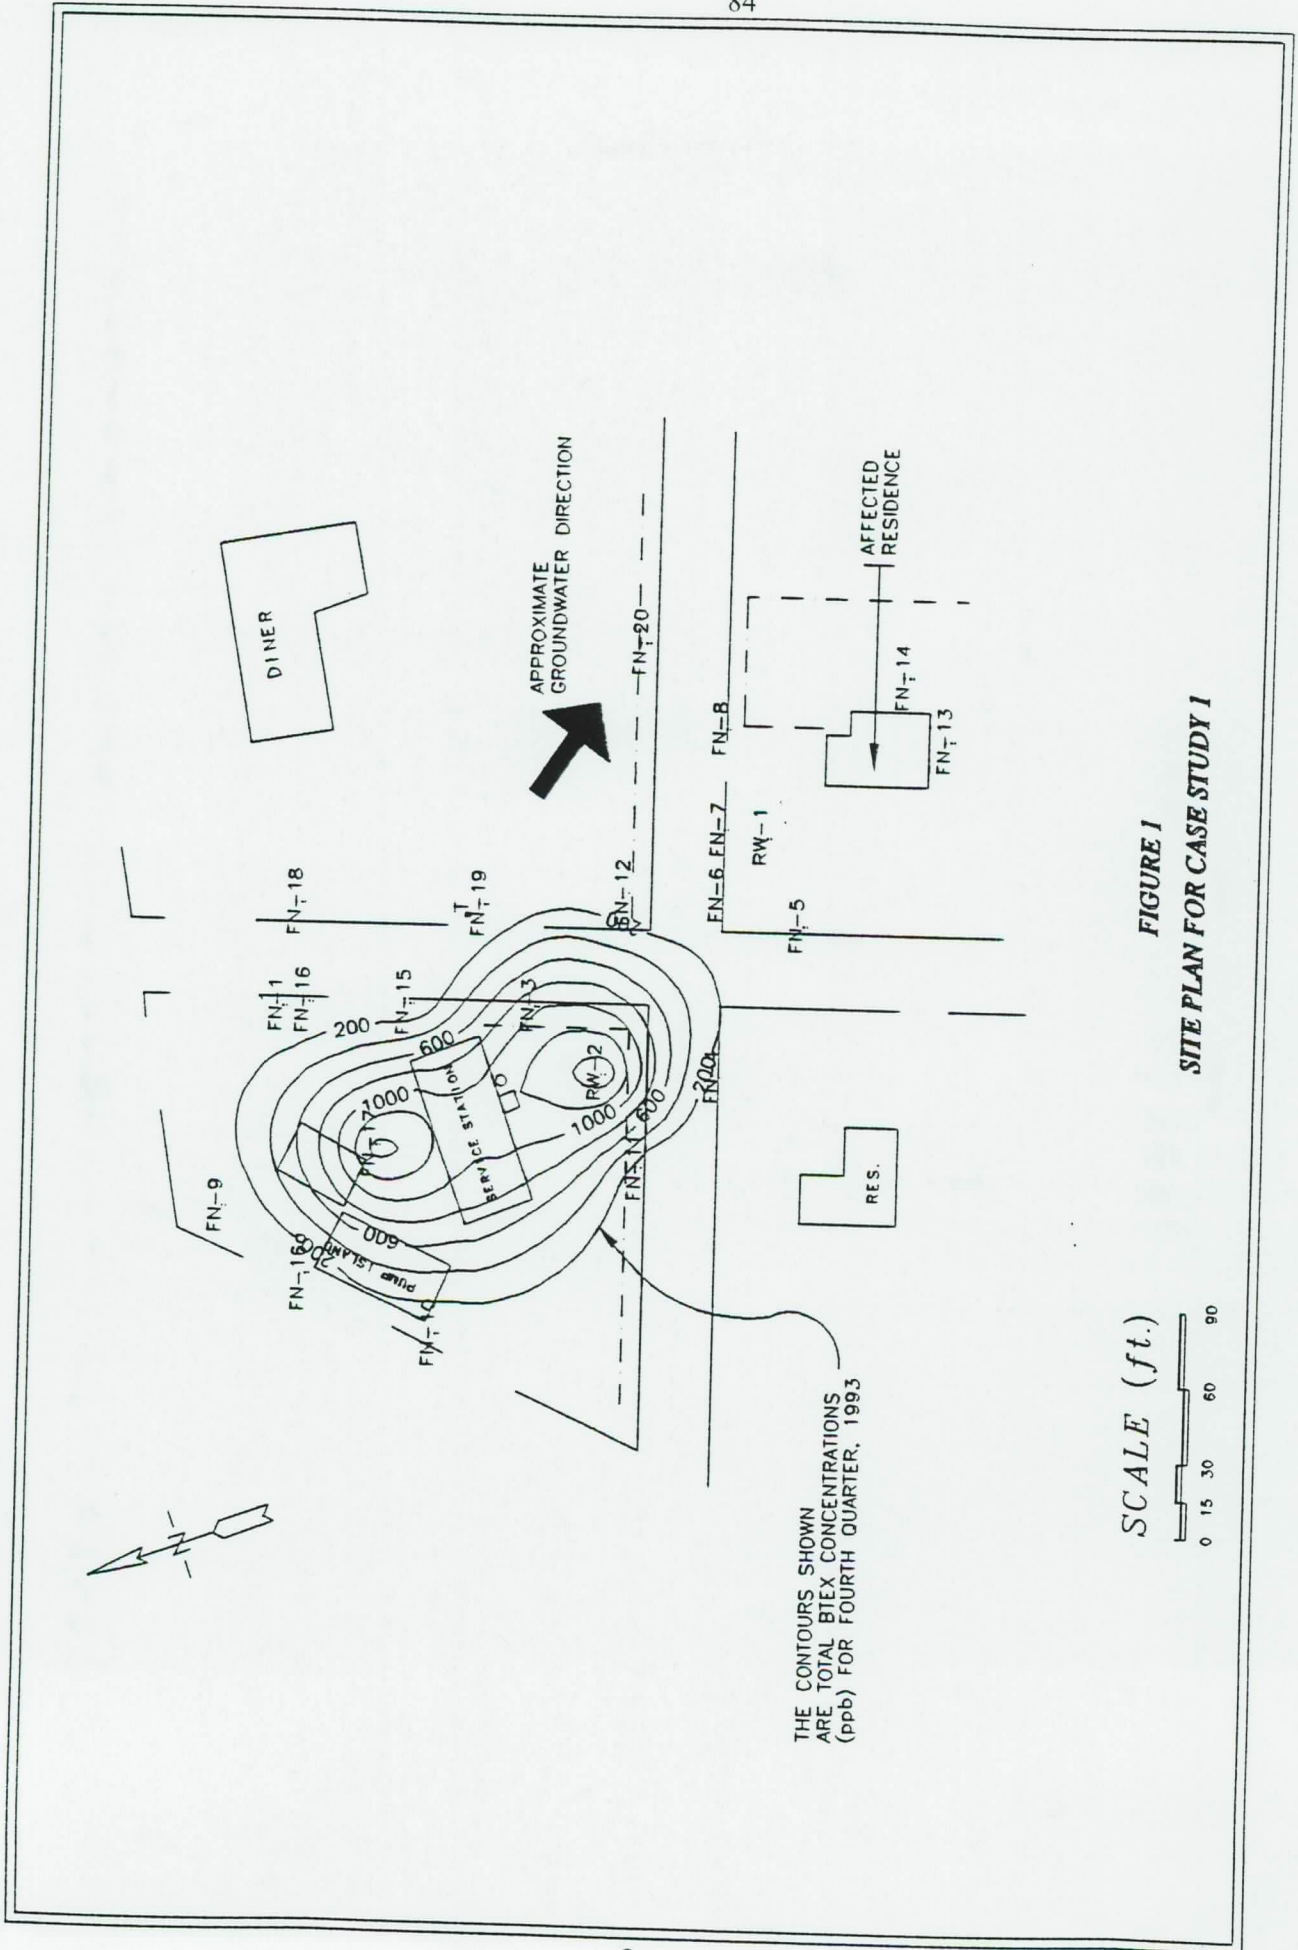
FIGURE 1
SITE PLAN FOR CASE STUDY I

The Massapequa Site is located in Massapequa, Long Island and includes a former service station and an "Affected Residence" as shown in Figure 1.

THE CONTOURS SHOWN
ARE TOTAL BIEX CONCENTRATIONS
(ppb) FOR FOURTH QUARTER, 1993

Investigations for the remediation of groundwater were conducted and a groundwater pump and treat system was installed in 1991. The system consisted of one (1) 6" diameter, 25' deep recovery well RW-1, which was located about 30' upgradient of the Affected Residence (Figure 1) so as to remove the dissolved hydrocarbons prior to their reaching the house. The design pumping rate was 40 to 60 gpm. Piping consisted of a 2" sch. 80 PVC pipe trenched below grade and across to the recovery shelter behind the service station building. The pumped water was passed through a 3' diameter, 20' tall air stripper, with two blowers producing 1,000 cfm. The discharge water was piped to the back of a catch basin and discharged to Massapequa Creek via an existing 24" storm drain. In anticipation of the need for a second recovery well on the gas station property itself, the air stripper was over designed for the proposed 40 - 60 gpm from the recovery well. The air stripper was designed such that effluent limitations will be met under flow conditions from both wells. The air stripper was cleaned quarterly with steam.

To improve the recovery rates, a second recovery well RW-2 was installed on the southeast corner of the service station (Figure 1) and put into operation in March 1993. Five (5)

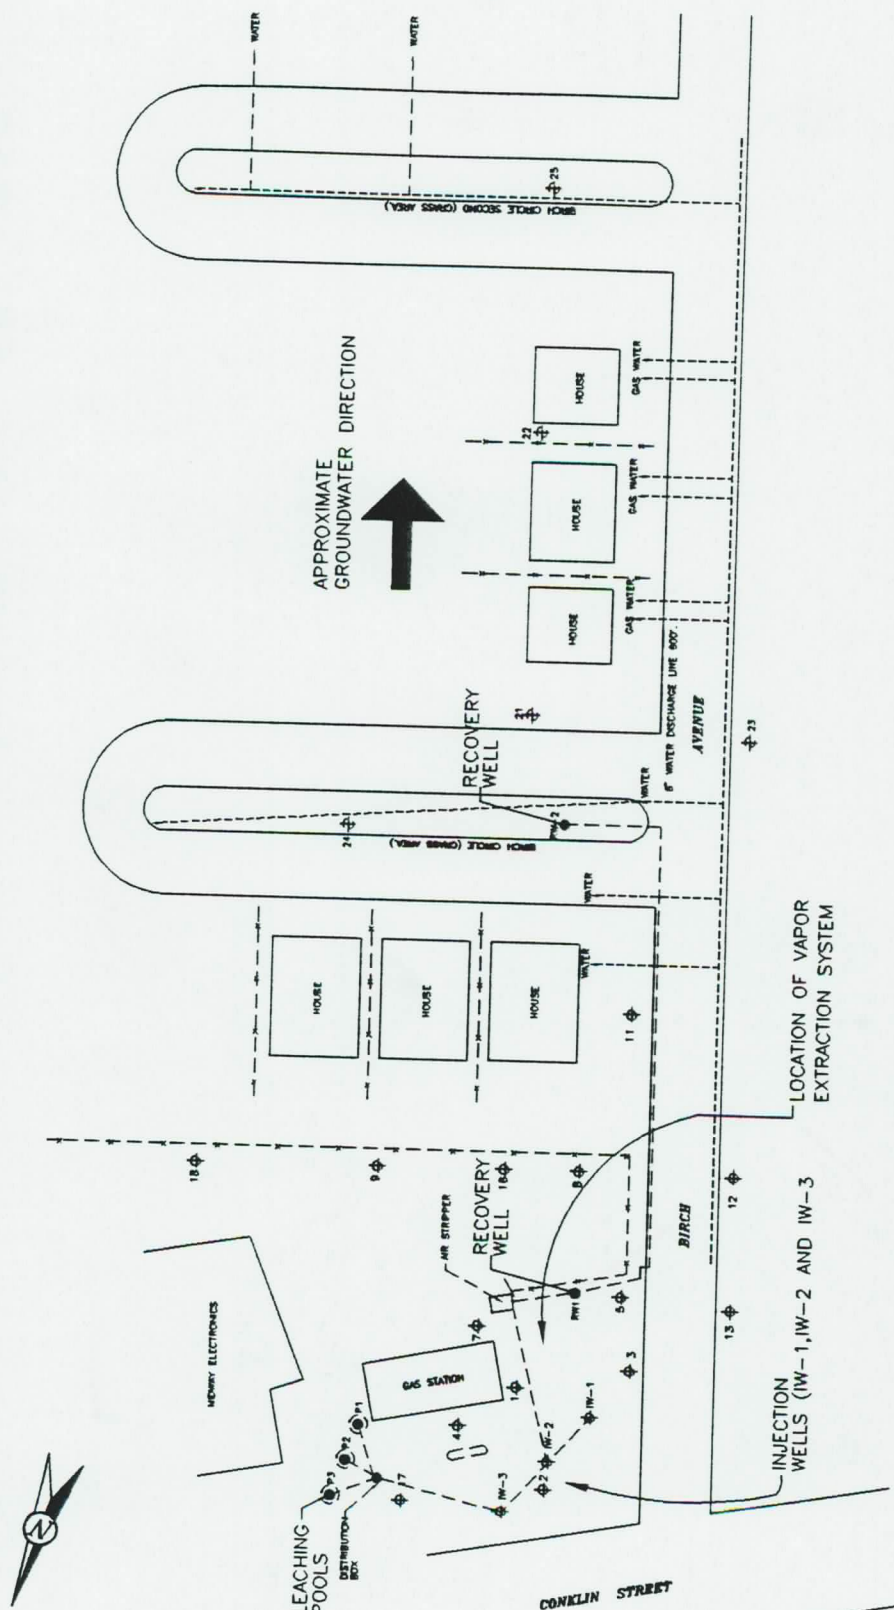
FIGURE 2
SITE PLAN FOR CASE STUDY 2

The East Farmingdale Site includes a former gasoline service station located in East Farmingdale, Long Island (Figure 2) and the gasoline contamination caused by this station. The groundwater contamination problem at this site consisted of a large dissolved hydrocarbon plume that was present on-site and had migrated with the groundwater flow approximately 400' southwest from the service station's storage tanks. The proposed remediation activities consisted of a groundwater pump and treat system and a soil vapor extraction system (VES).

An additional recovery well (RW-2 in Figure 2) was designed for installation in the first Birch Circle for containing and treating the highest portion of the dissolved hydrocarbon plume which migrated off-site. An 8" diameter, 45' deep well (30' screen in water, 10' additional screen, and 5' of solid PVC) was designed. The Johnson Continuous Wrap PVC well screen was chosen. The use of continuous wrap screen will increase the effective screen openings by approximately 50% over slotted screens. To reduce the turbidity of the water in order to prevent clogging of the treatment system and final discharge, a slot size of 0.05" which, based on sieve analysis of site soils, would allow only 50% of the formation to pass was chosen. The filter packing was minimum 2" thick Morie #2, which is large enough to be 100% retained by the well screen but small enough to reduce the entry of fines. The designed screen has a 12.7 gpm, 1' yield limit with an entrance velocity of 0.10 ft/sec. This recovery well will have a maximum yield of 300 gpm and, based on earlier investigations, will be pumped at 100 gpm during remediation. The existing air stripper was used for treating the pumped water from both wells RW-1 and RW-2. Pumped water from RW-2 was directed to the air stripper by a 4" PVC pipe located approximately 2' below grade.

A vapor extraction system (VES) was designed and installed for remediating residual unsaturated zone contamination and for capturing volatilizing hydrocarbons from the groundwater. The installed VES consisted of nine (9) wells. Of these four (4) wells are existing monitoring wells MW-1, MW-3, MW-6, and MW-7 (Figure 2). The other five (5) are new 2" PVC wells installed in the tank area to a depth of 25' (22' screen and 3' solid). The pipes were

Recovery well RW-1 was shutdown at the end of May 1994. By the end of June 1994 the highest total BTEX concentrations were centered at monitoring well MW-6 (859 ppb) which is closer to RW-1 (Figure 2). Therefore, RW-1 was turned on and RW-2 was turned off at the end of July 1994. This process of turning the two recovery wells on and off as necessary to capture
