# BEYCESULTAN

SETON LLOYD

Published by  
THE BRITISH INSTITUTE OF ARCHAEOLOGY AT ANKARA  
140, CROMWELL ROAD,  
LONDON SW7 4HE

LATE BRONZE AGE ARCHITECTURE

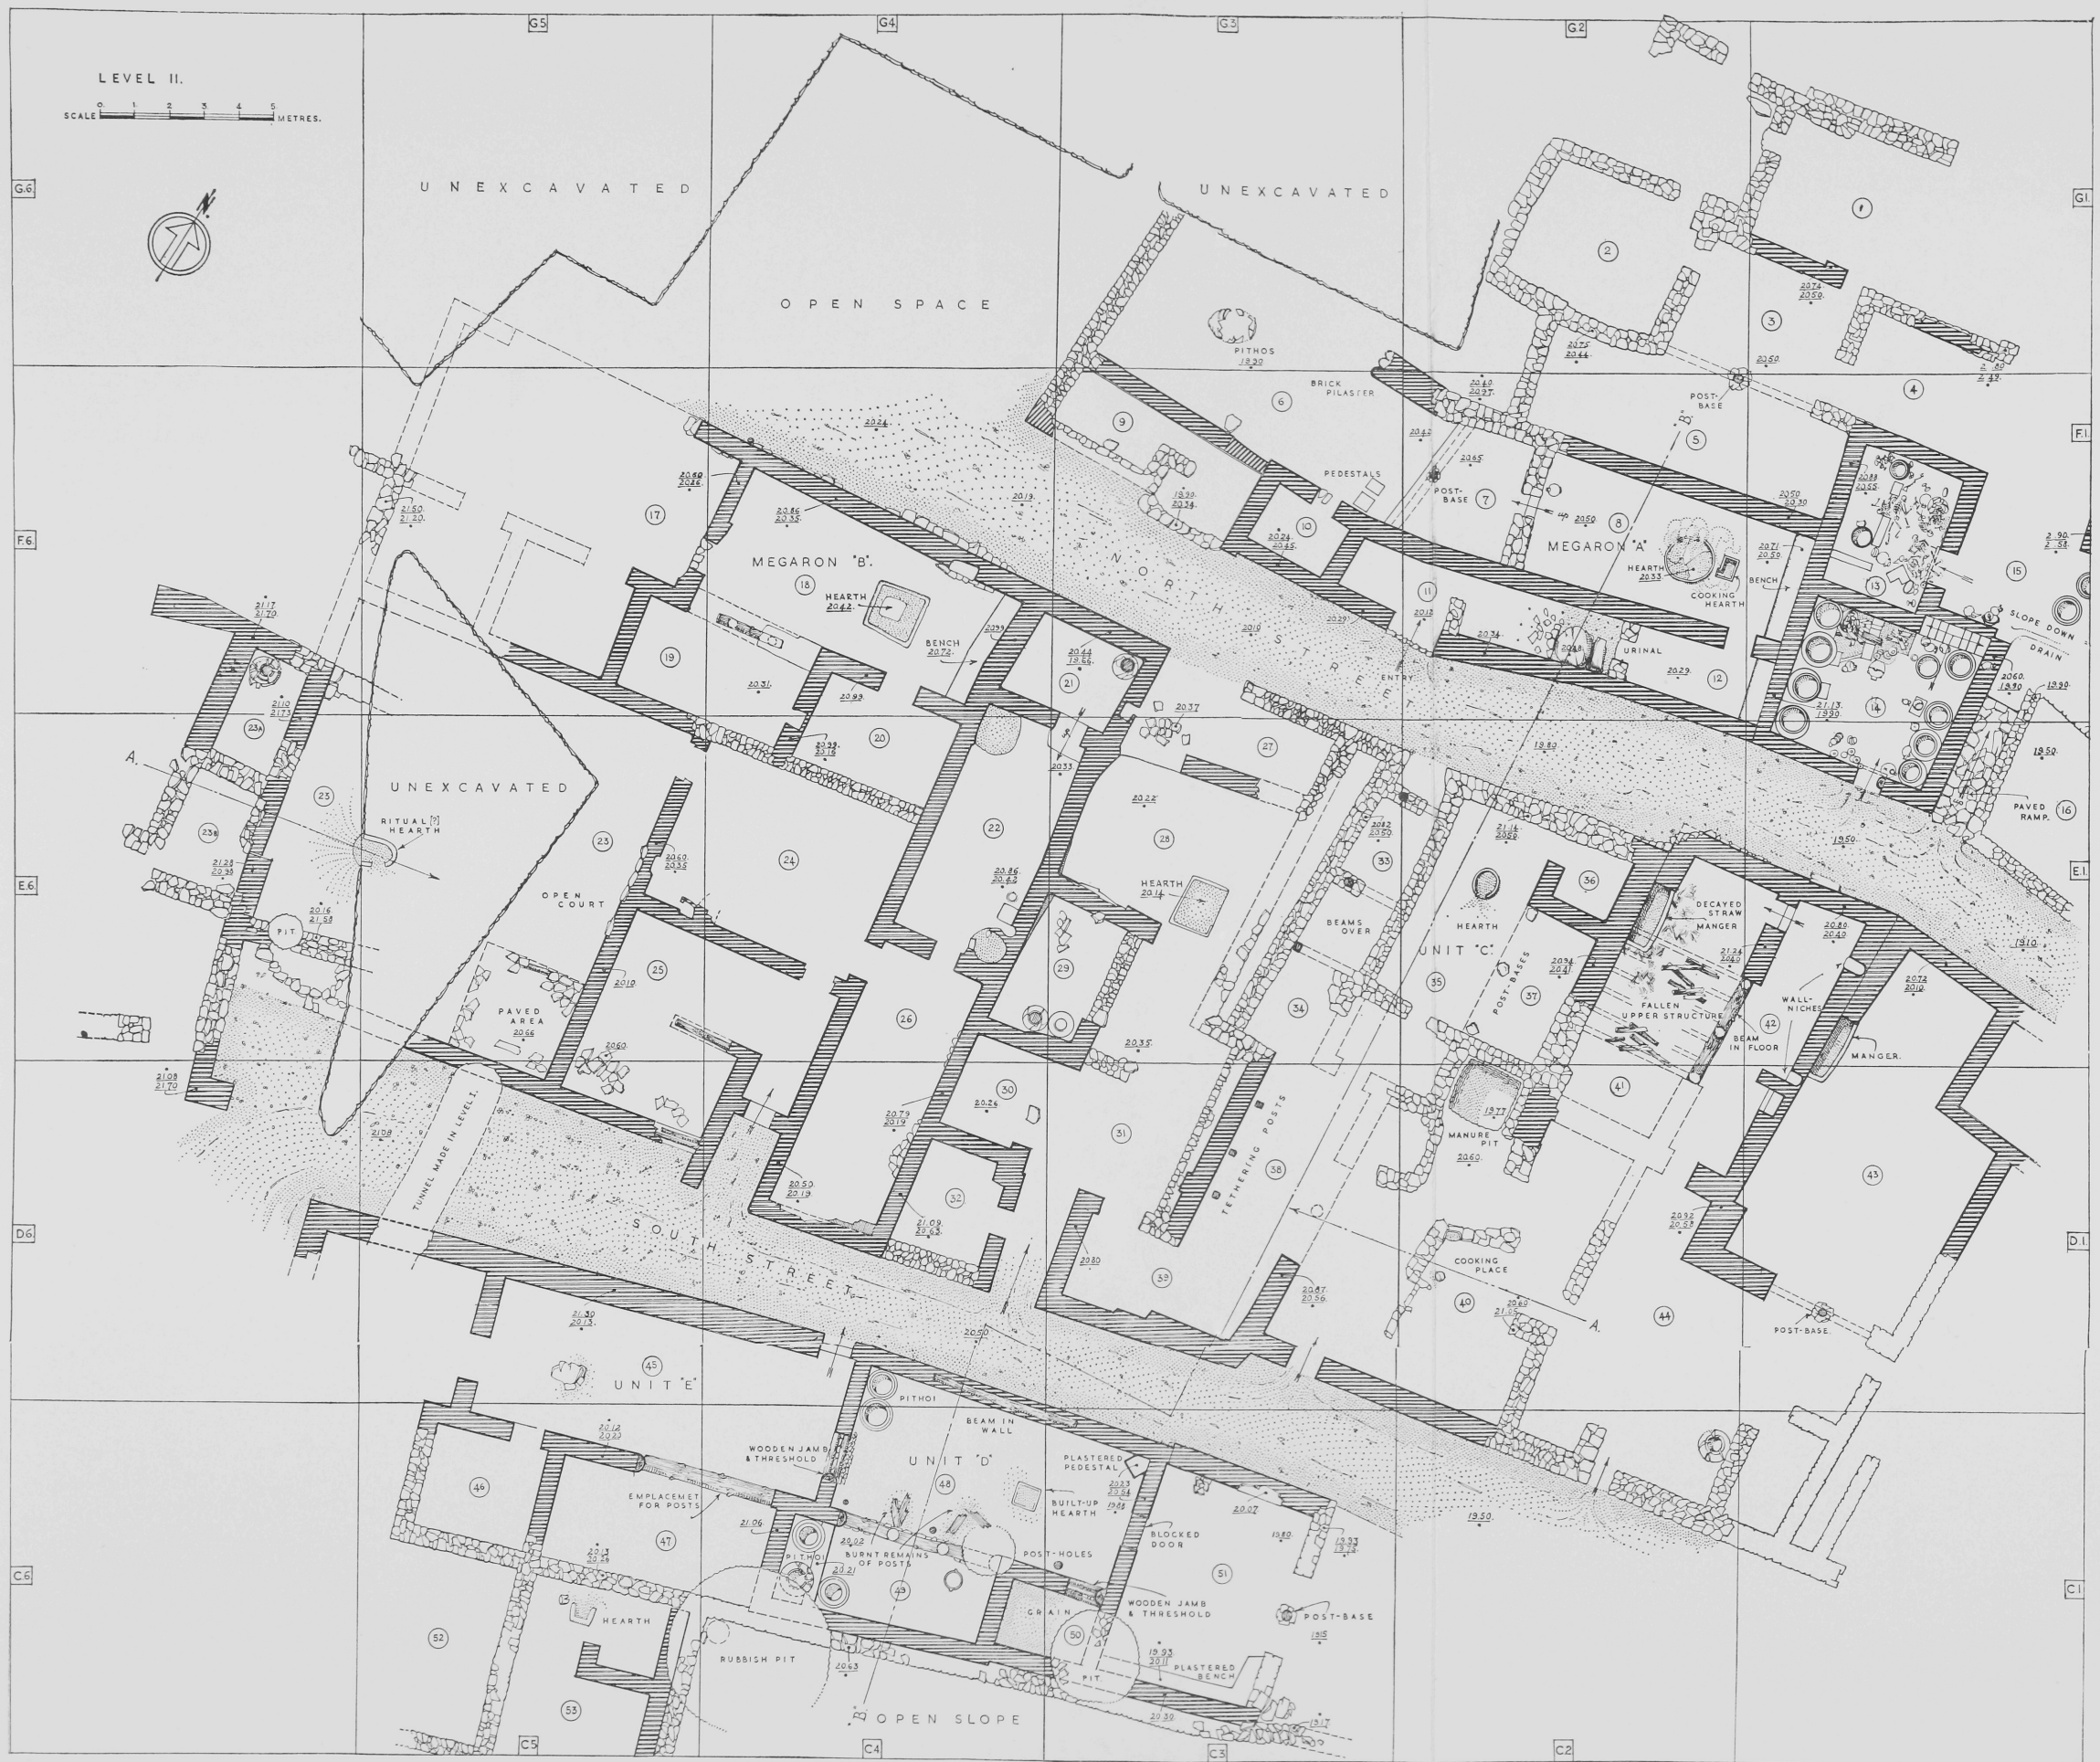
FIG. 3. Plan of Level II on east summit

The building here seems to consist of a standard unit, twice repeated with an interconnection. Each unit comprises, first a rectangular court (Nos. 45 and 48), which we take to have been open to the sky, since the span in both cases would appear too great for an unsupported ceiling and no post holes of any sort were found. Annexed to this are two further rooms; a sort of "portico" living-room, open to the court on one side, and a smaller chamber approached through a door, possibly a bedroom. The better preserved unit (Unit D), excavated in 1954, has a court (*No. 48*) measuring 8.50 × 4.00 m. (Pl. IIIb). Near the centre there is a built-up hearth with a clay curb around it and in the north-east corner a square brick pedestal, placed diagonally to the room. Two large *pithos* water jars stand side by side in the north-west corner. It is connected with the adjoining unit (Unit E) by a doorway which is sufficiently characteristic of structural practice in these buildings to merit further description (Pl. IIIc). The threshold consists of two untrimmed logs of wood, held in place by a bedding of small stones and plastered over. One jamb—on the side on which the door is hung on its pivot-stone—is a simple plastered reveal. The other, against which the door closes, is lined with the semicircular half of a tree-trunk, exactly fitting the thickness of the wall, itself also plastered over. This device seems to be an invariable practice and may have facilitated the fast-closing of the door. It is not new in this period, as it has already been recorded in a building of the Early Bronze Age (*cf.* Vol. I, p. 40). Room 49 is in this case the "portico" living-room. It is open to its complete length on the court side, the threshold consisting of a single tree-trunk, built into the wall at either end and wedged with lines of stones on either side. Evenly placed at two points in its length were the charred remains of two substantial wooden posts which had stood upon it, supporting a beam across the opening. One jamb, at the western end was lined with half a tree-trunk like the door we have described. The other, as confirmed by the arrangement in the adjoining unit (Room 47), had a square reveal covered only with plaster. This has suggested to us that two of the openings separated by the vertical posts may have been screened, perhaps with reed matting. The third would then have had a door, closing against the built-in wooden jamb.

Next to the "portico" is a smaller room (*No. 50*) entered by a doorway of standard construction, which in this case would appear to have been a store. It was filled to a considerable depth with carbonized grain, among which lay some objects including a bronze spearhead and a lead-headed club. The room also contained a very large number of broken "fruit stands"; fragments of nearly forty vessels in all, together with broken fragments of *pithoi* which had probably contained the grain. At the west end of the "portico" stood three tall *pithoi*, two of them held in position by a low sleeper-wall. Elsewhere, a large two-handled basin lay intact upon the pavement.

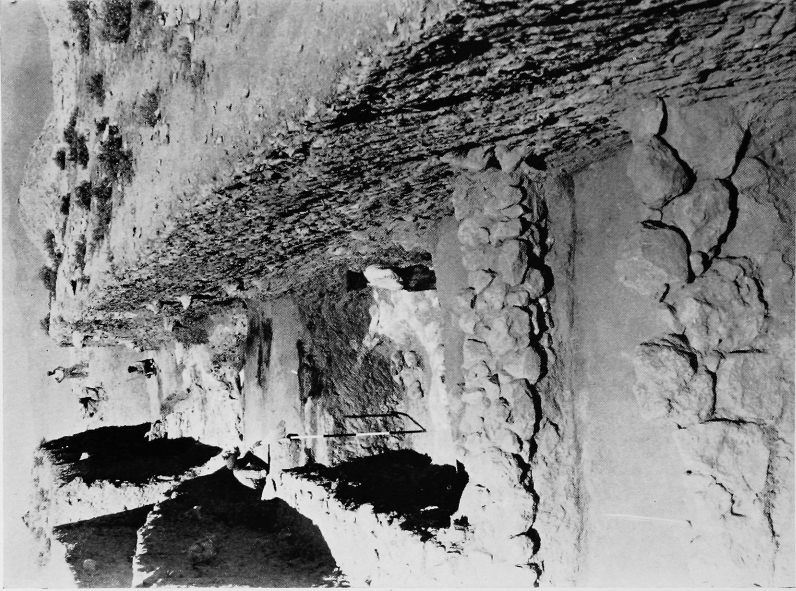
(b) Foundations of Level III enclosure-wall and terrace (foreground), with burnt buildings of Level V. Trench K

It should be mentioned at this point that, during the excavation of these houses, evidence was found of a secondary occupation during which some rebuilding of the houses took place and walls were occasionally re-aligned. For the purpose of allocating small objects and pottery this subphase has been referred to as *Level IIIa*. In Fig. 2, only the basic layout (*Level IIIb*) is recorded. Something should also be said about the enclosure wall, concerning which, all the evidence available suggested that it already existed in the Level IIIb phase. Its location at two points on the north and west side of the settlement resulted from the extension during our first season of two search-trenches, "N" and "K" in these two directions respectively. In Trench N, it was reached at a point 23 m. north of the Level III street (where the beginning of Trench Y is indicated in Fig. 2). Here it took the form of a substantial stone wall 60 cm. thick, separated by a filling of hard clay from a narrower retaining-wall built at a slightly lower level, as though to form a terrace around the base of the fortification (Pl. IIa). This interpretation of the evidence provided by Trench N was satisfactorily confirmed later in the season, when precisely the same arrangement of enclosure wall and terrace were once more encountered at the extreme western end of Trench K, once more in a setting contemporary with the foundation of the Late Bronze Age settlement (Pl. IIb).<sup>2</sup>

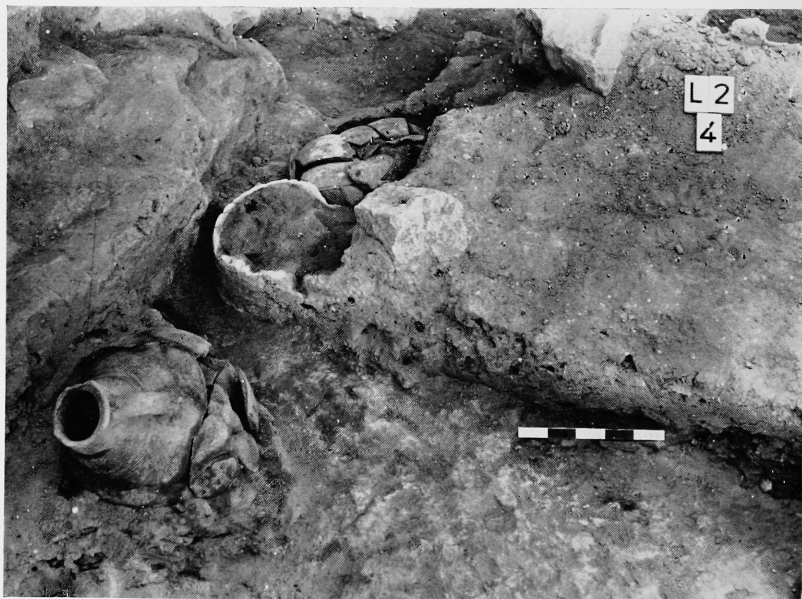
(b) Line of plaster indicating shape of an attached column in portico of Megaron A

“The porch itself had at some time completely collapsed and been rebuilt from its foundations upwards. But the remains were sufficient to suggest some architectural treatment of the *antae*, perhaps corresponding to the so-called *parastades* found by Schliemann in the Troy II *megara*. The base was found of a single three-quarter column, moulded in brickwork and outlined in mud plaster, its position suggesting that three might have occurred side by side.”

We are now able to publish a photograph of this detail (Pl. IV*b*), in which it will be seen that the brickwork of the *anta* rests directly upon the crushed remains of a large pottery vessel, which could, we thought, just possibly have been a foundation deposit.

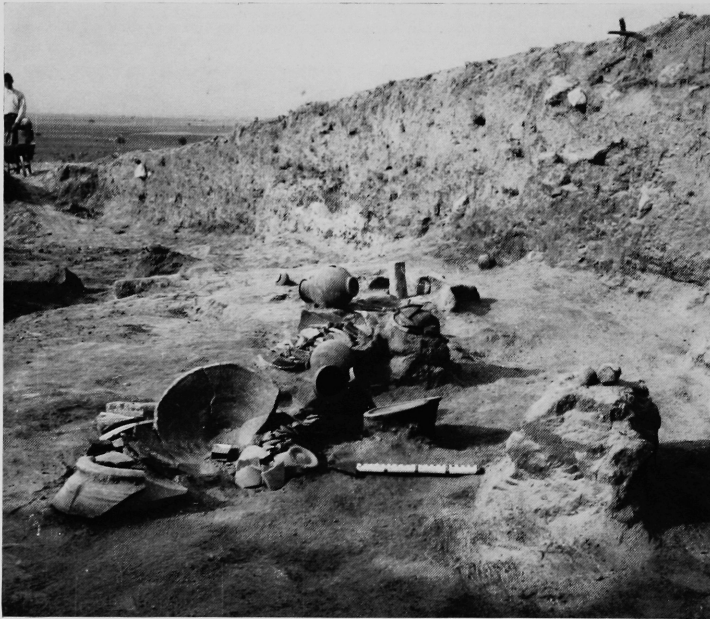
(b) Concentration of pottery over 'sink' between Rooms 4 and 1

The wall between Rooms 4 and 1 seemed at some time to have been demolished, and astride its foundations lay the greatest concentration of pottery yet found in this area (Pl. XIV*b*). There was here a kind of stone sink, with a drain leading northward under the floor of Room 4. Standing in it was a large water container, too fragmentary to reconstruct, with smaller vessels piled around it, including many "chalice"-type drinking cups, "fruit stands" and simpler bowls. The "plastered bin" (No. 6) to the east of this area seemed likely to be intrusive from the Byzantine level above. Also on the east side and unconnected with the house just described, was a long narrow room (No. 7) from which we recovered three fine examples of the "beak-spouted" jug, so characteristic of this period.

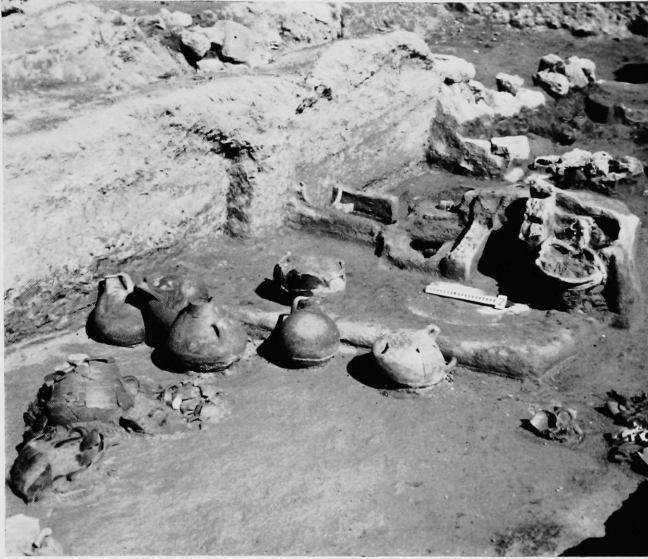
(a) Level II. Ritual structure in East Shrine with votive vessels in foreground

The *shrine-room* itself measured  $9.60 \times 3.25$  m. The ritual structure was as usual placed in the centre of the room towards the northern end and was again a rather elaborate affair (Pl. XIXa, Figs. 11 and 12). Like that in the
