UR EXCAVATIONS

VOLUME V

THE ZIGGURAT AND ITS
SURROUNDINGS

SIR LEONARD WOOLLEY

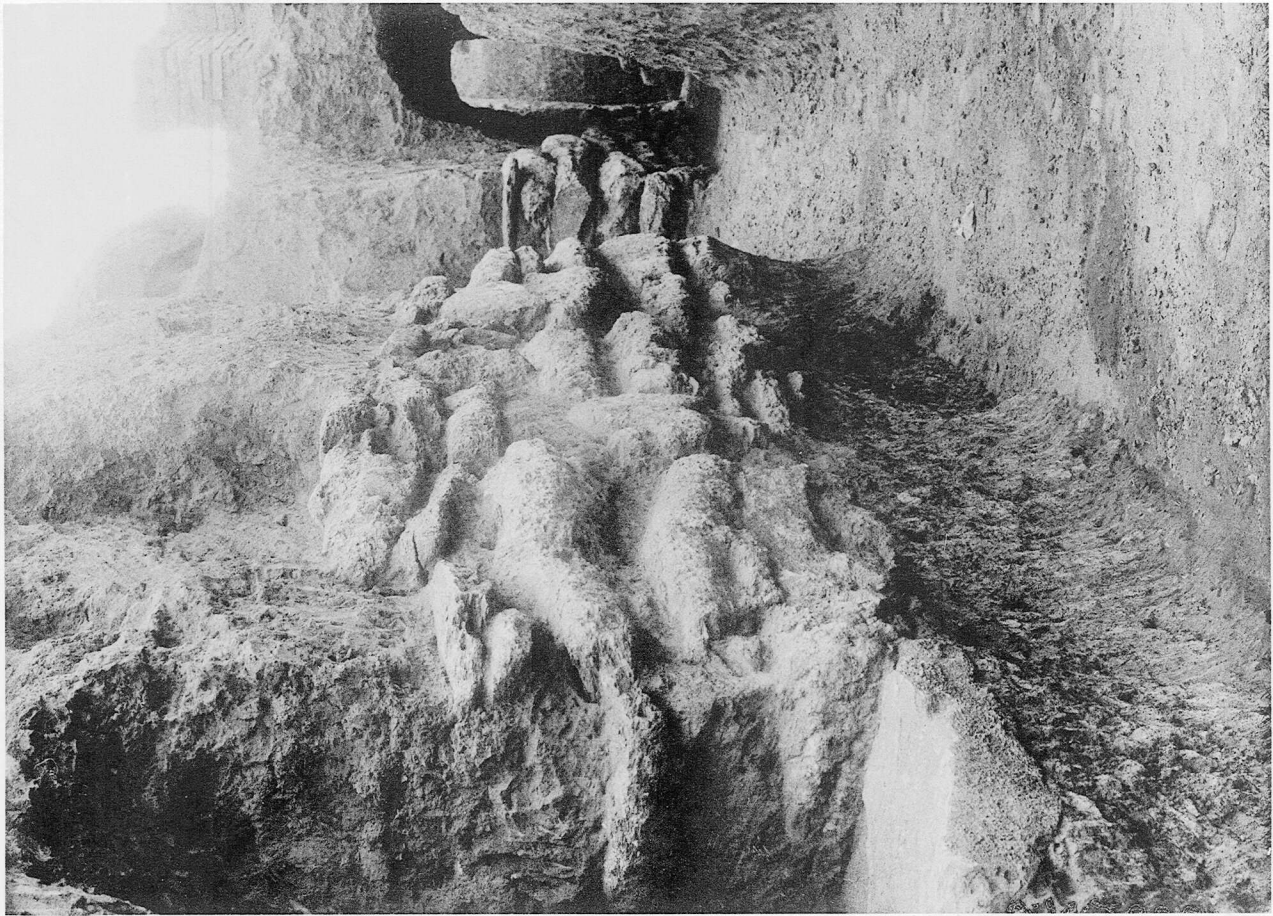
a. Limestone foundations of retaining-wall, Archaic I, NW. side. (See p. 7)

Let into the stonework were found fragments of two burnt bricks, so slightly plano-convex as to be almost flat, 0.165 m. × ? × 0.05 m. (Pl. 1 b), and where the stonework had been removed there were found, apparently *in situ*, burnt bricks 0.24 m. × 0.16 m. × 0.06 m. Bricks of Ur-Nammu and two of his terrace wall cones were found against the ruined stone facing, and it was perfectly obvious that the destruction was due to his workmen who were cutting back the old terrace edge to make room for their own foundations; the complete disappearance of the wall-face after the first twenty metres may well be due to there having been here a projection corresponding to that in the Warad-Sin edition of the terrace which lay in the line of the Ur-Nammu work and was therefore entirely removed (Pl. 2 a).

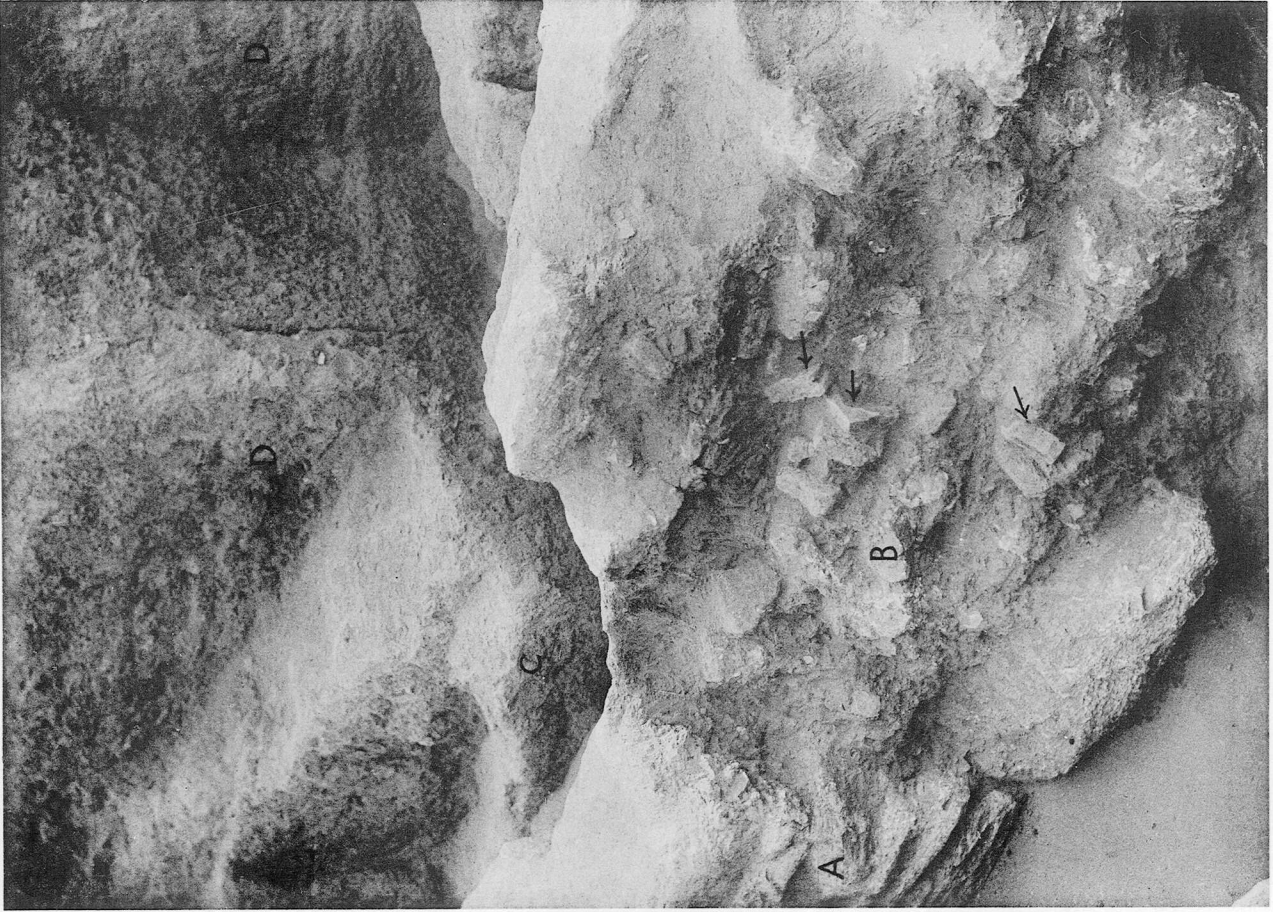
b. NW. retaining-wall: A, stone face, and B, stone core of Archaic I wall; C, mud-brick wall of Archaic I; D, mud-brick wall of Archaic II. Arrows show burnt plano-convex bricks mixed with the stonework. (See pp. 1, 8)

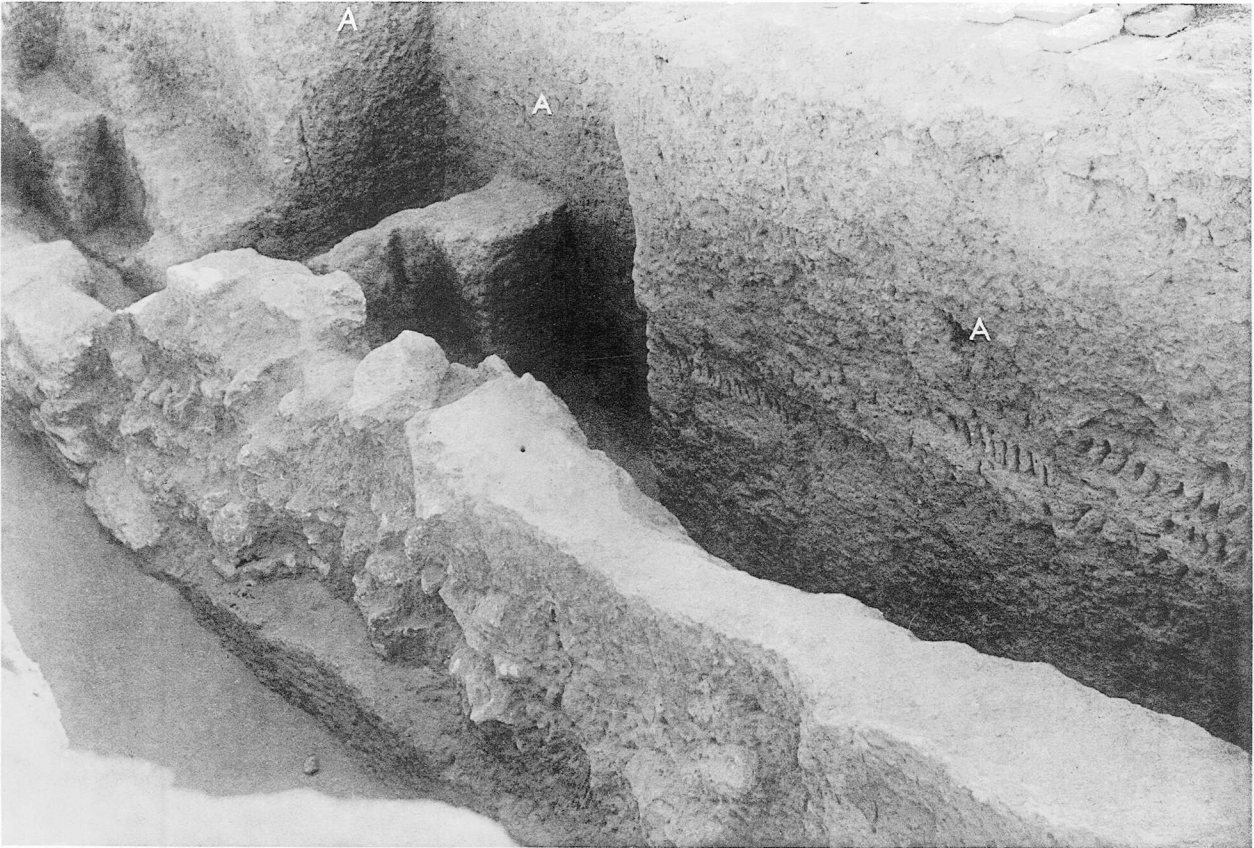
a. The NW. retaining-wall, Archaic I, illustrating the removal of the stonework by Ur-Nammu's workmen: A . . . A: wall of Period Archaic II. (See p. 8)

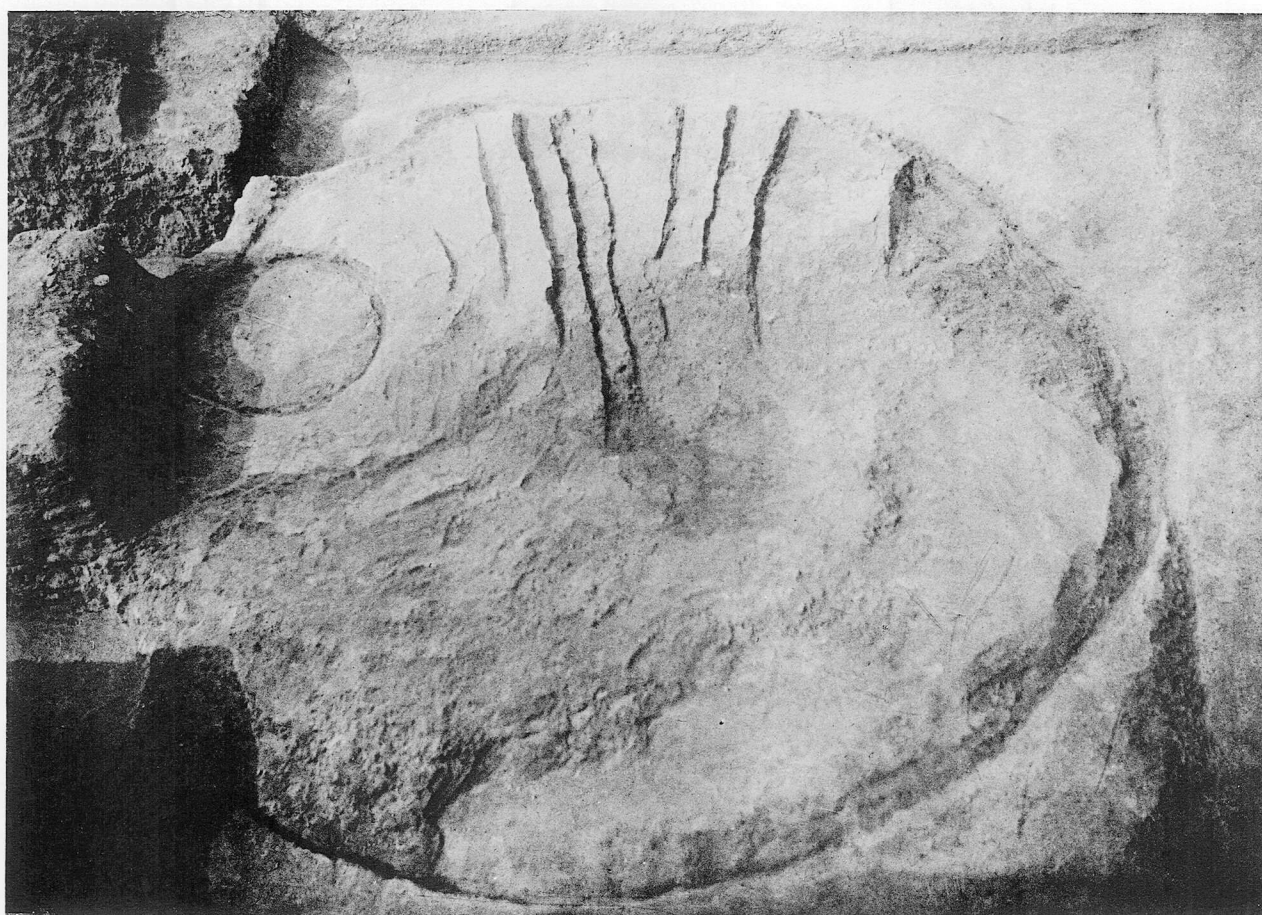
b. Archaic I: room EE: the furnace with its often-repaired floor. (*See p. 12*)

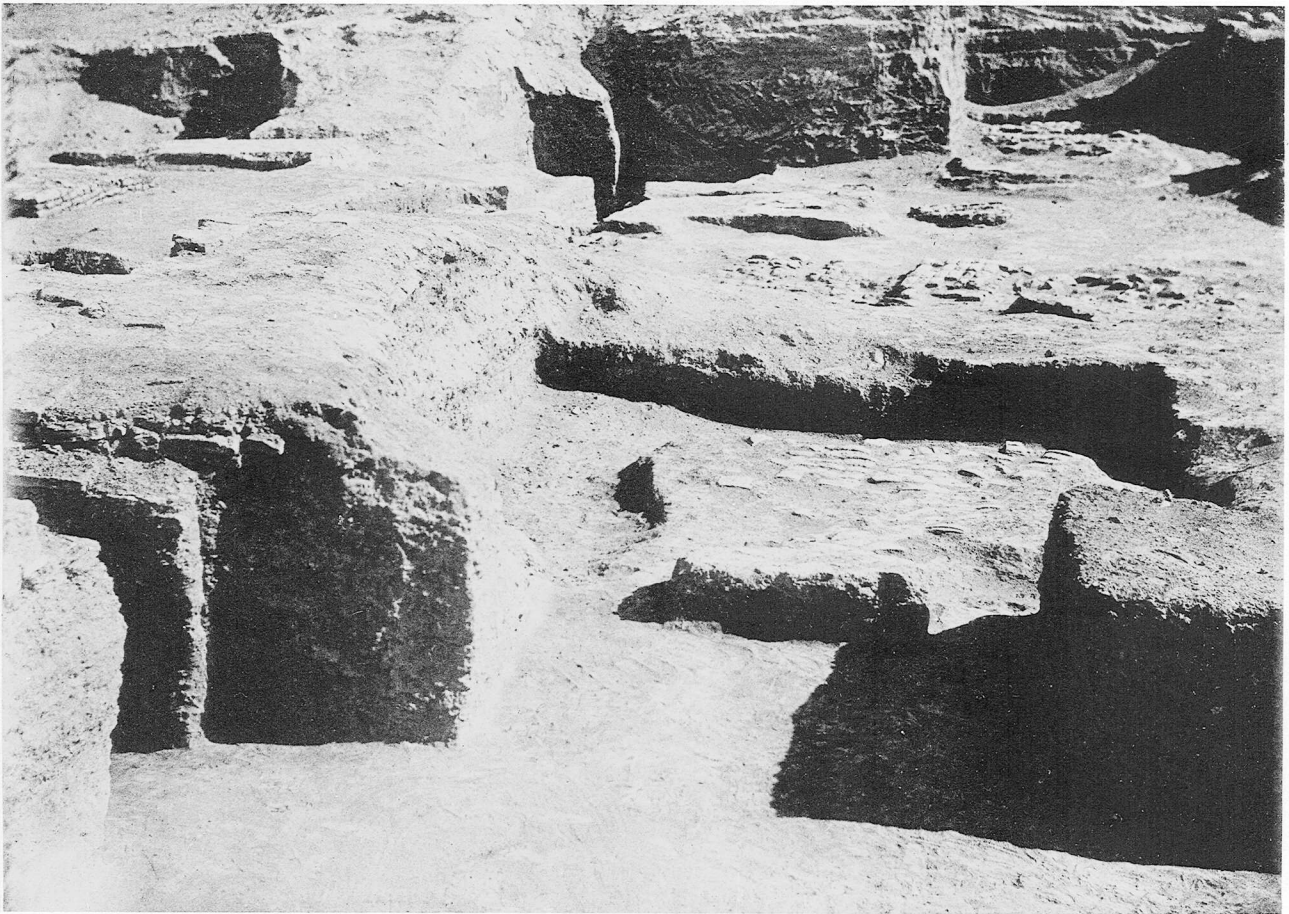
a. Archaic I: north corner of court FF, looking into room DD with its floor reinforced with potsherds, and to the court BB beyond. (See p. 12)

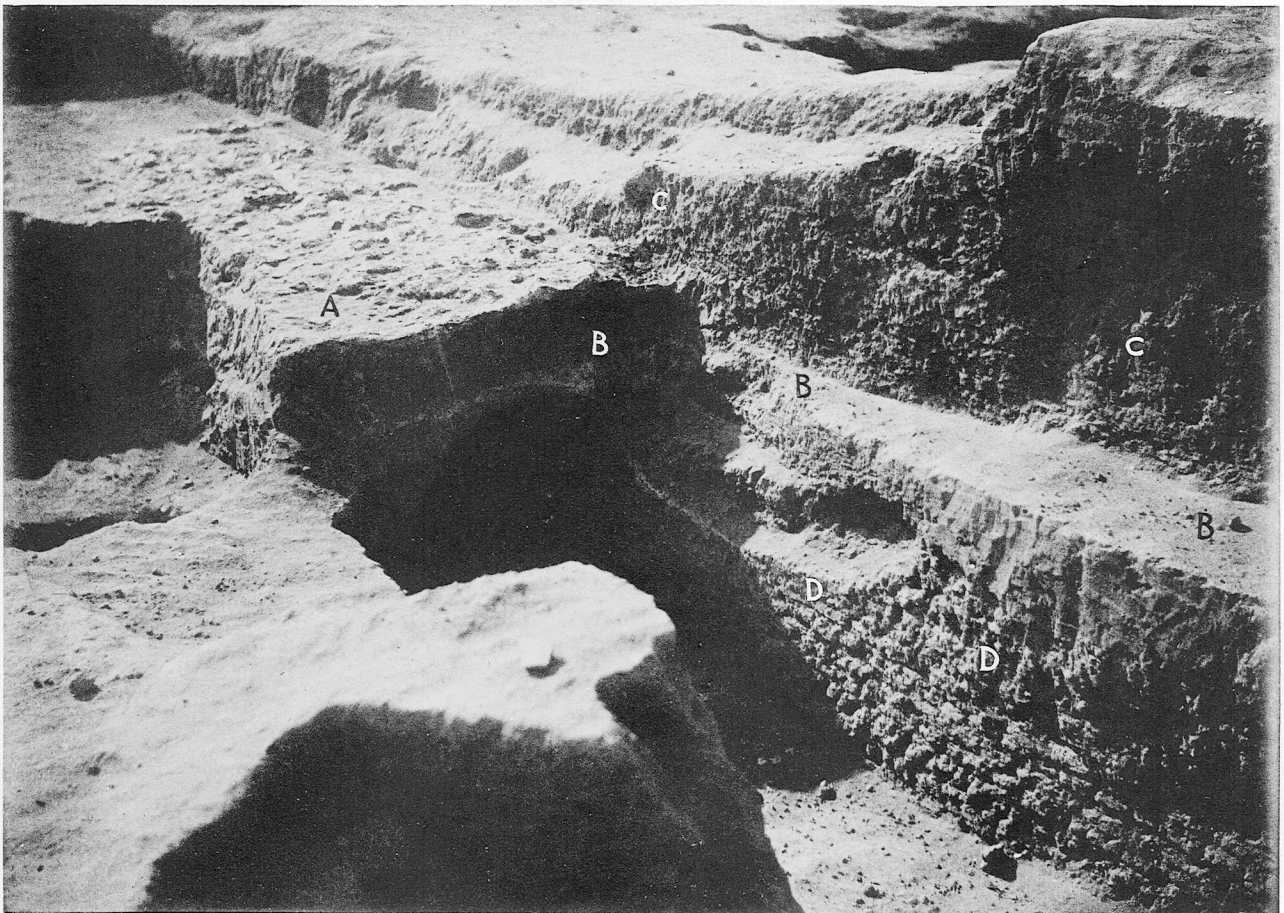
b. The SW. end of courtyard BB, showing: A, the raised floor of burnt brick and bitumen; B . . . B, the early whitewashed floor; c . . . c, wall of Archaic I; D . . . D, wall of Archaic II. (See pp. 3, 13)

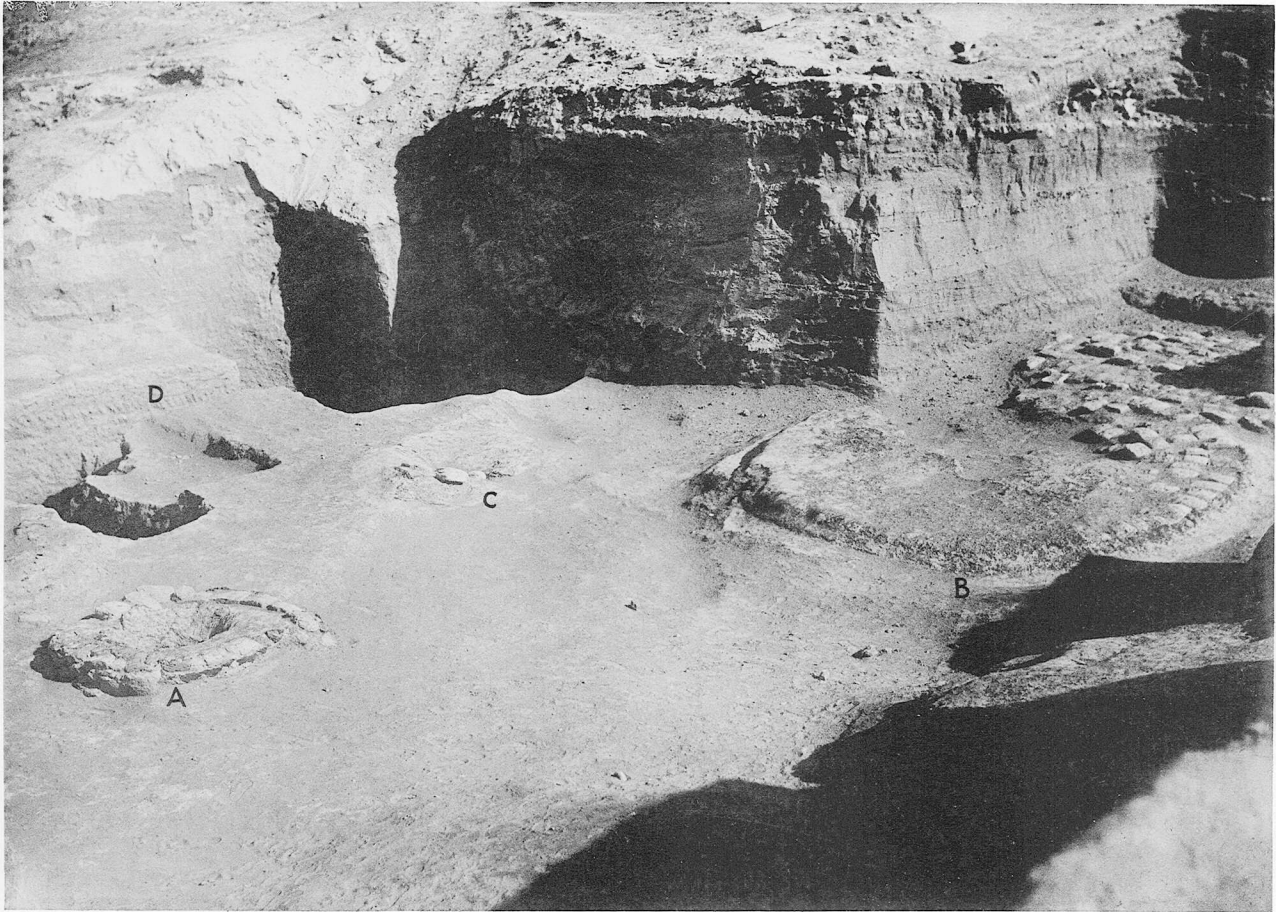
a. The NE. end of the courtyard BB, showing: A, the bitumen-lined basin; B, circular brick base; C, remains of second similar base; D, NW. wall of courtyard. (*See p. 14*)

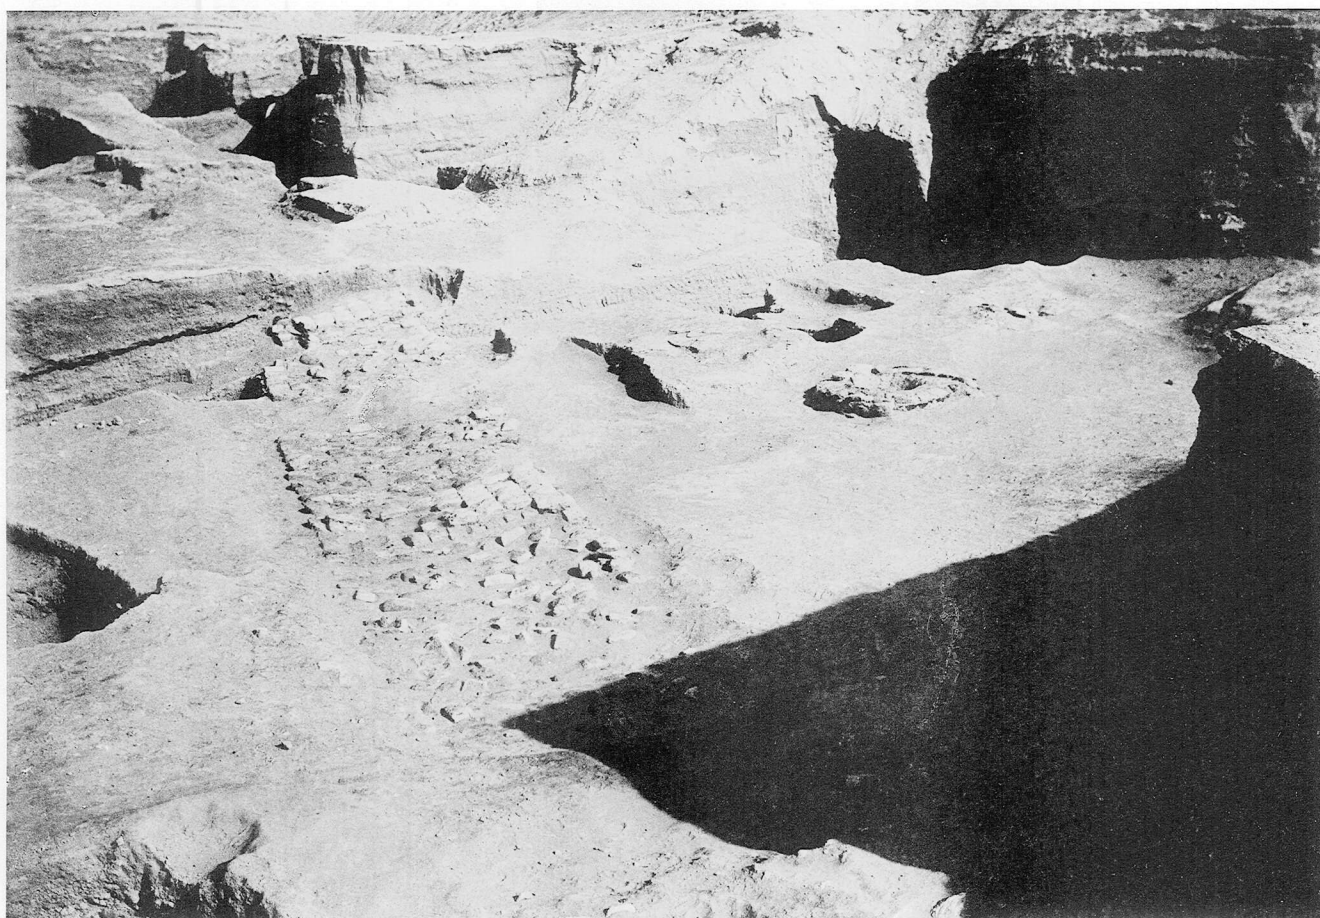
b. The courtyard BB, Archaic I, showing the remains of the high brick causeway. (*See p. 14*)

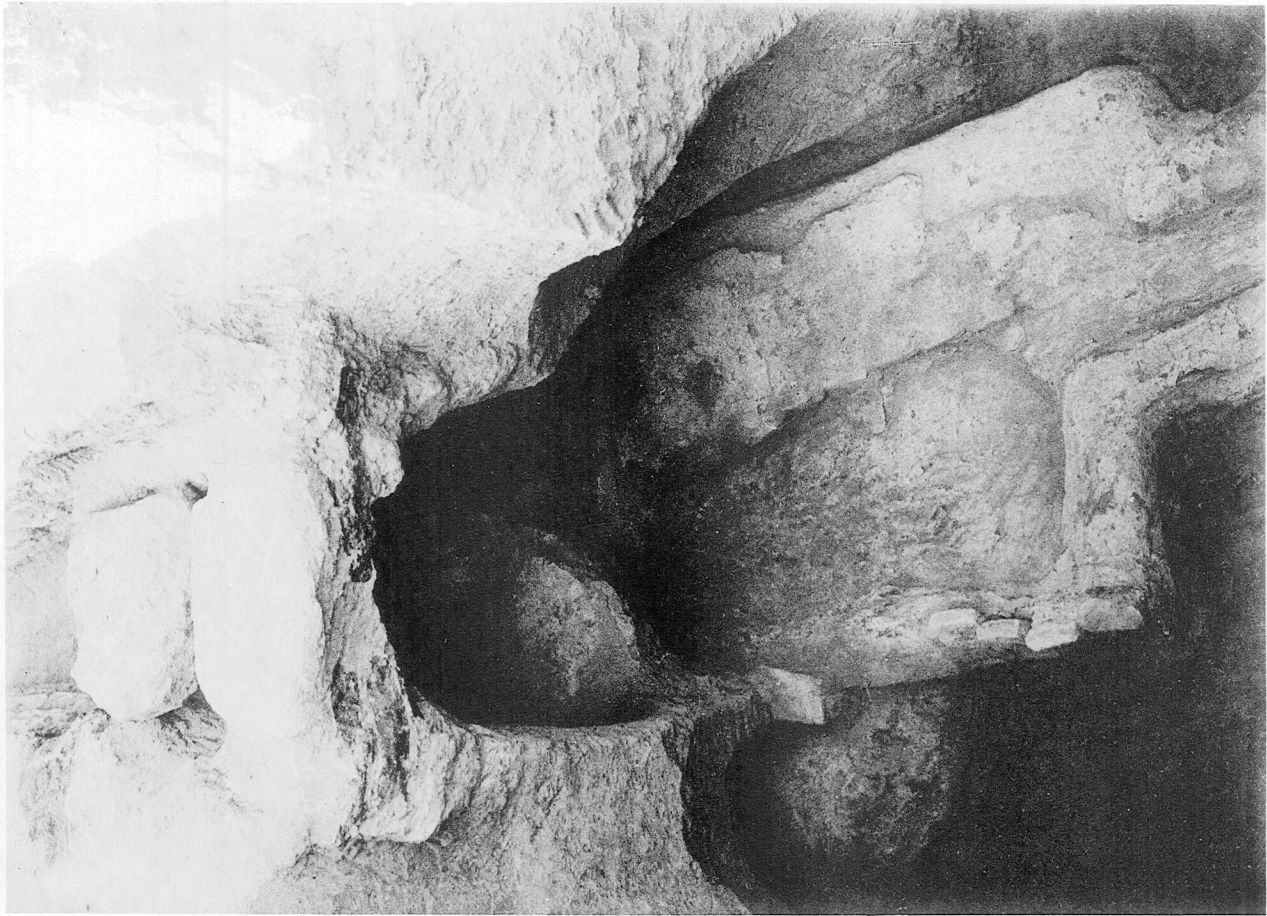
a. The exit of the drain in the SE. wall of courtyard BB, Archaic I: the stone-covered drain of the 3rd period, with older exits below. (See p. 16)

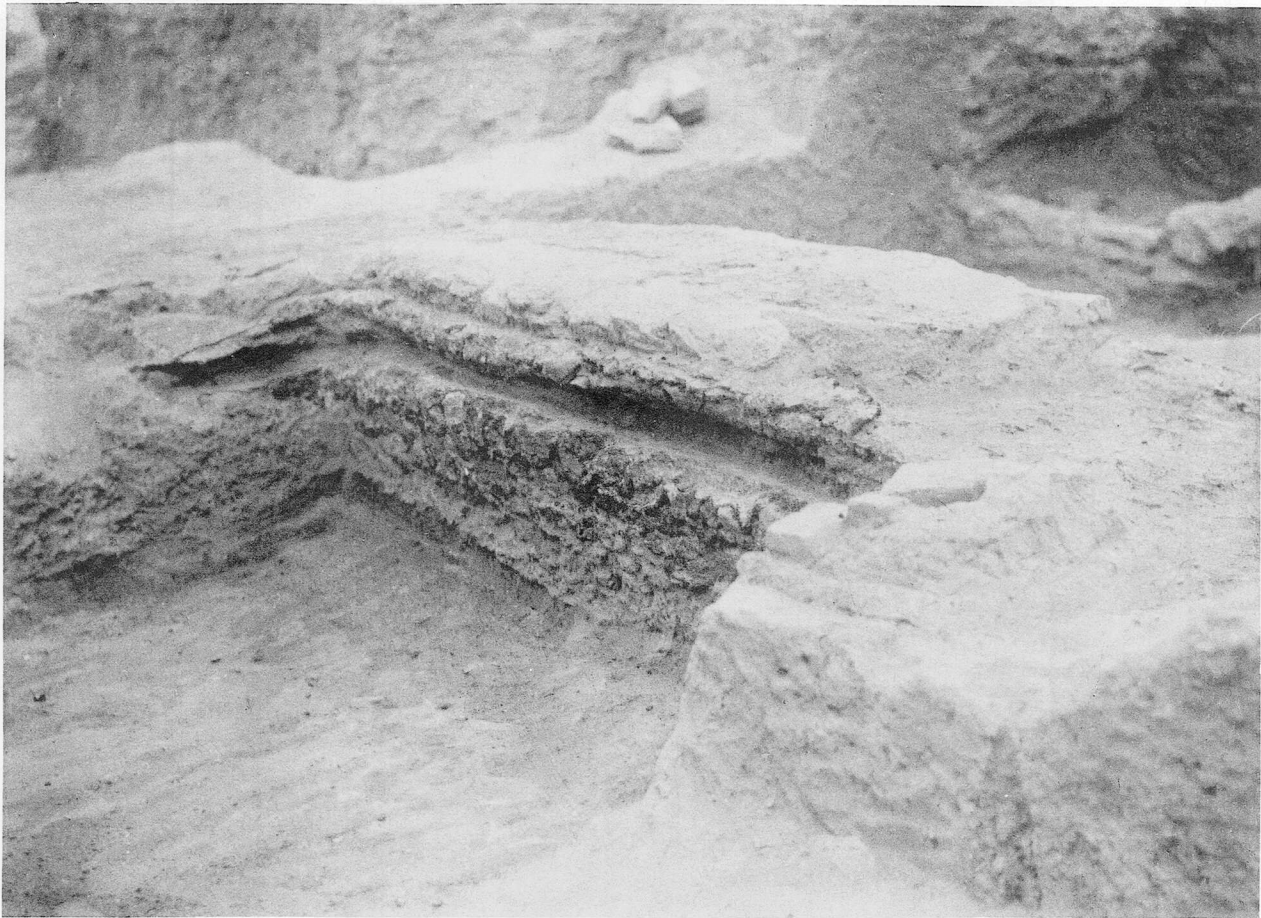
b. The same: bitumen-coated floor of passage between rooms 1 and 2, showing the three levels due to repairs, and brick and stone imposts by the doors. (*See p. 21*)

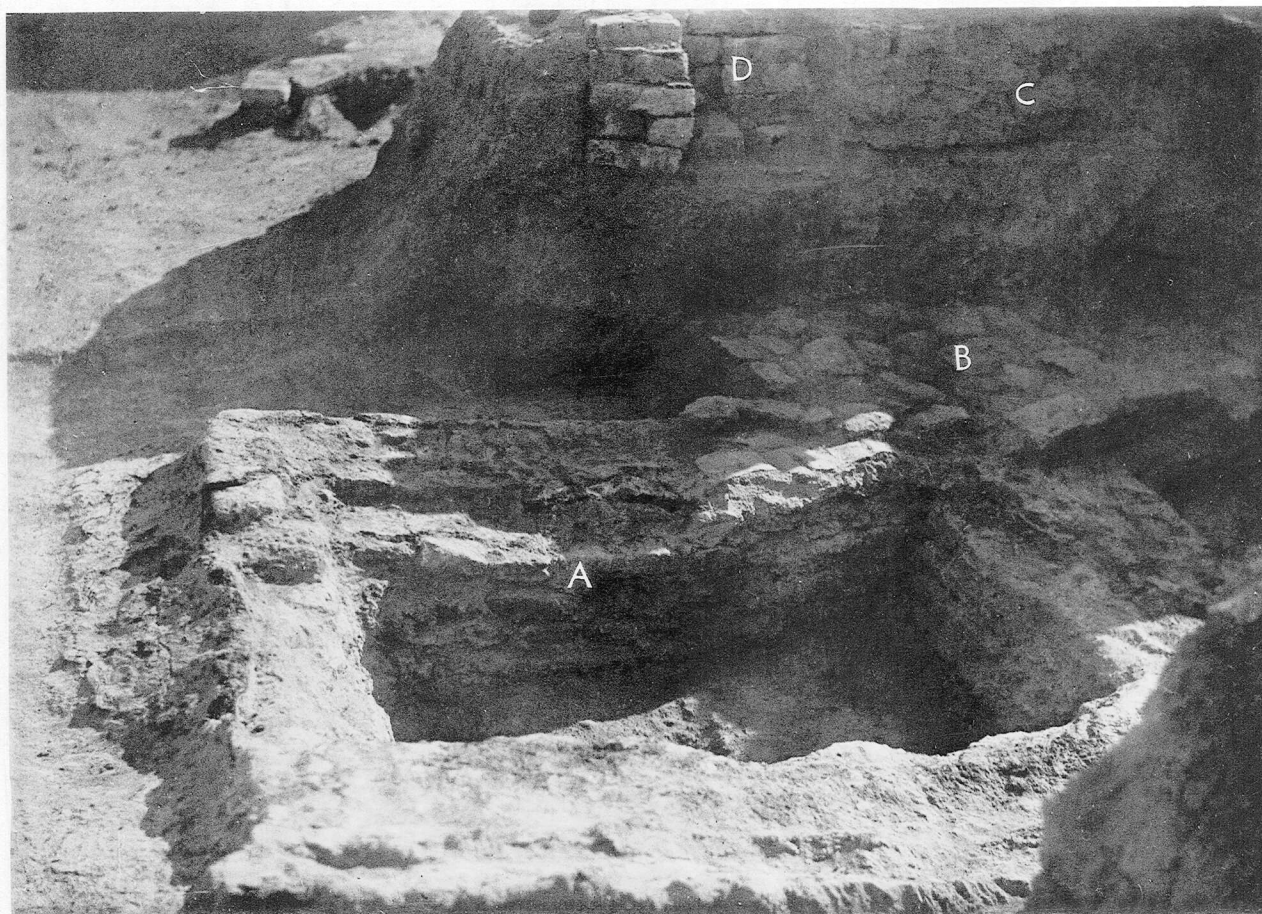
a. The NW. 'kitchen' building, Archaic I, room 2: A, the 'basin'; B, burnt-brick paving; C, mud-brick wall-foundations of Ur-Nammu; D, burnt-brick foundation-box of Nur-Adad cut down into the Third Dynasty brickwork. (See pp. 21, 38)

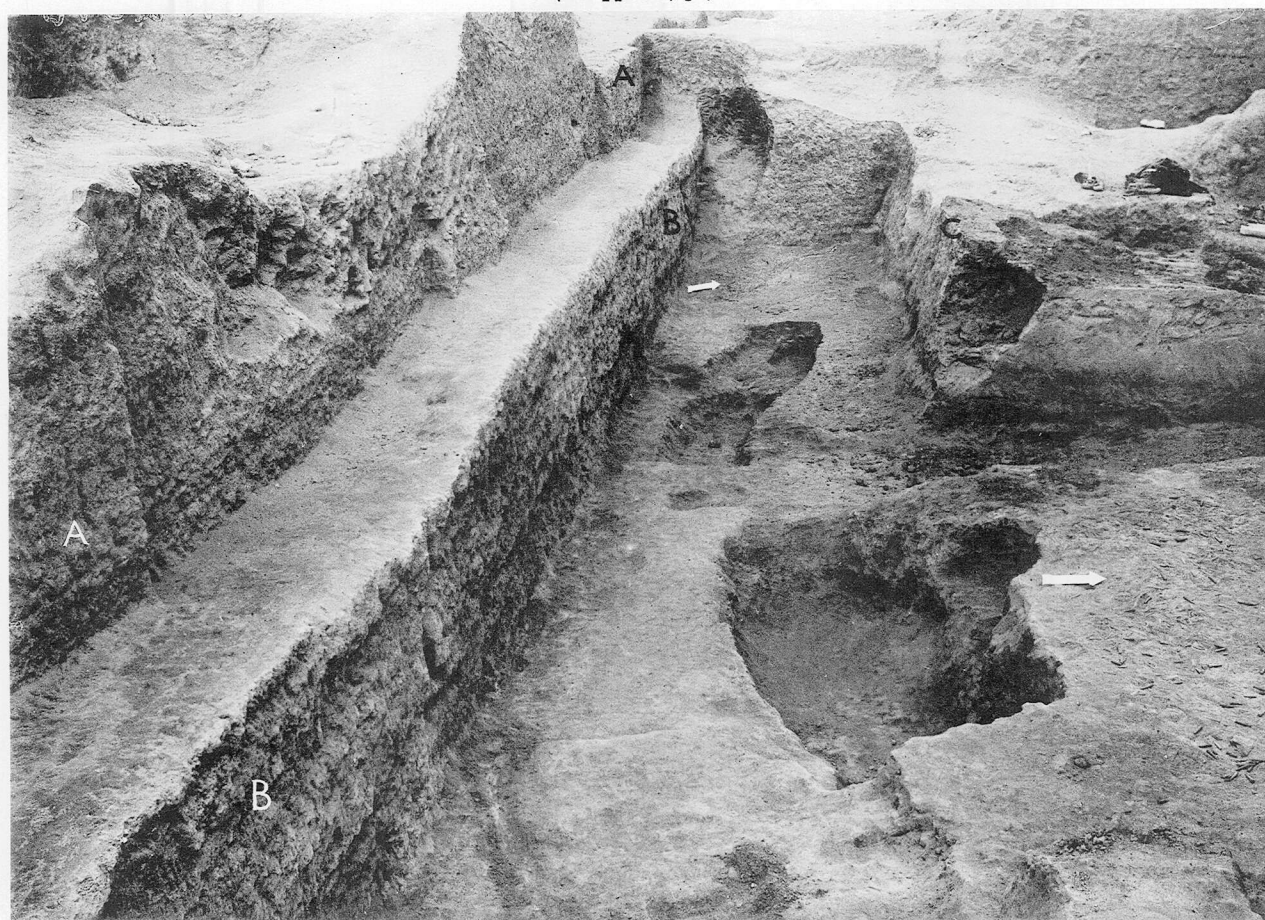
b. The buttressed inner face of the NW. wall of the First Dynasty terrace (A . . . A) resting on (B . . . B), the older Archaic II wall; c, remains of Archaic II B platform. Arrows point to deposits of wall-mosaic cones. (See pp. 3, 5)

In the west corner of the terrace there was found running parallel to the NW. enceinte wall a mud-brick wall, poorly constructed, with a sharply battered face and behind it an earth packing topped with two courses of mud-brick paving, which implied a raised platform 1.00 m. high separated from the terrace edge by a sunken passage; what the reason for the platform may have been there was nothing to show. The wall of it was not bonded into the enceinte wall and its foundations rested on the terrace floor, so that it was definitely of late construction: its bricks measured *c.* 0.19 m. \times 0.11 m. \times 0.05–0.06 m. and were of light sandy clay set in greenish mud mortar: the floor bricks measured 0.22 m. \times 0.12 m. \times 0.06–0.07 m. and were of greenish clay set in reddish mortar; see Pl. 13 *b*, 'Archaic II B platform'.

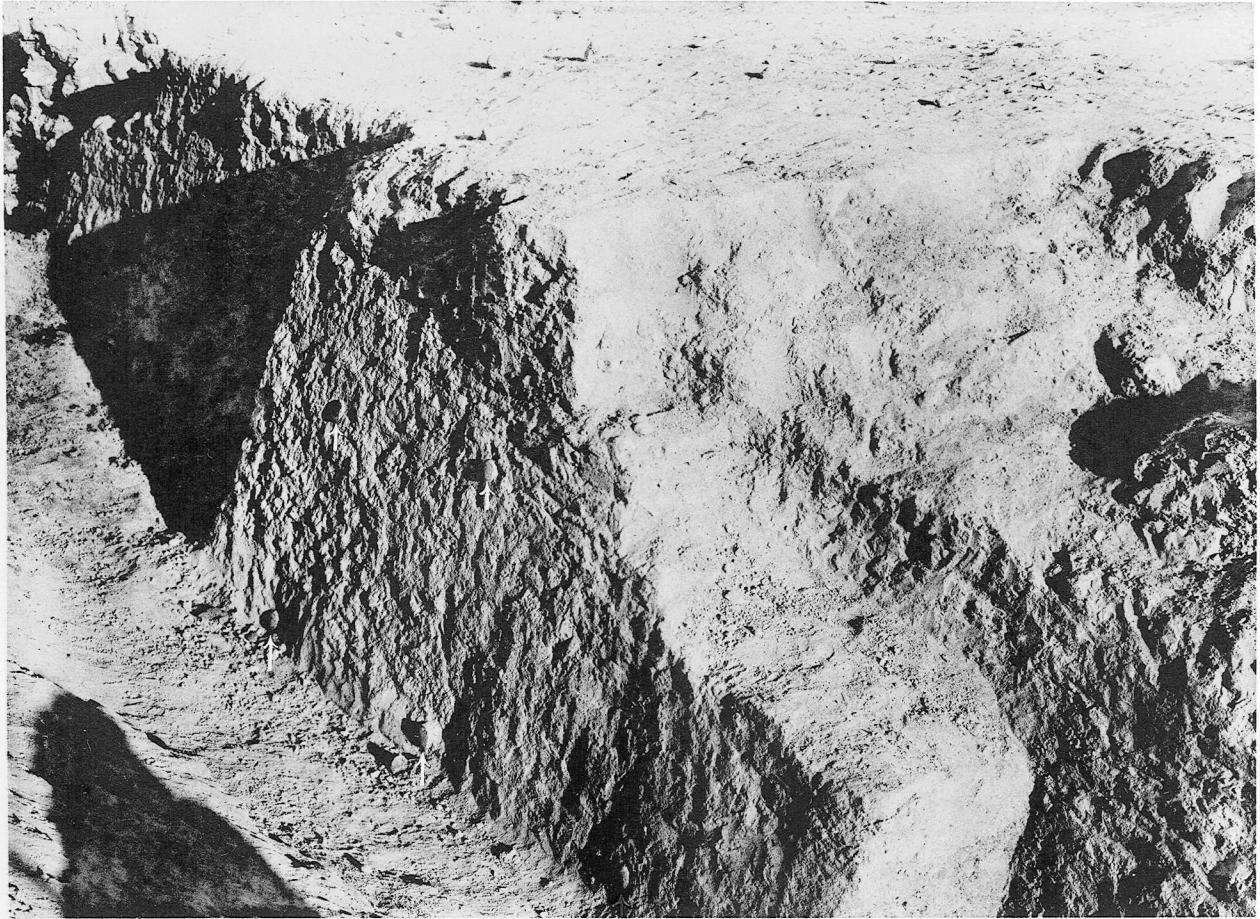
a. The terrace wall of Ur-Nammu, NW. side: arrows show position of foundation-cones. (*See p. 24*)

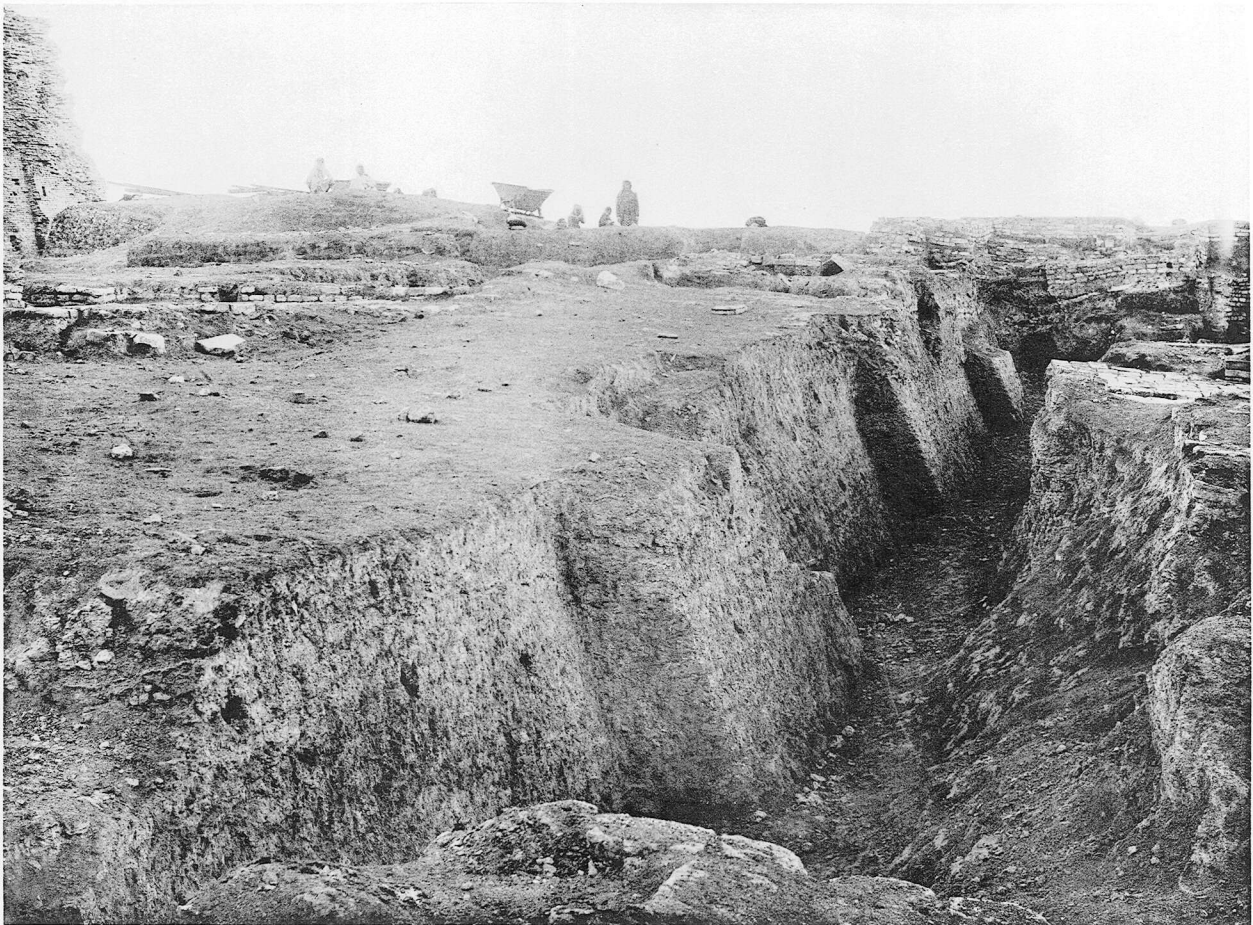
b. The terrace wall of Ur-Nammu, NW. side: general view. (*See p. 24*)

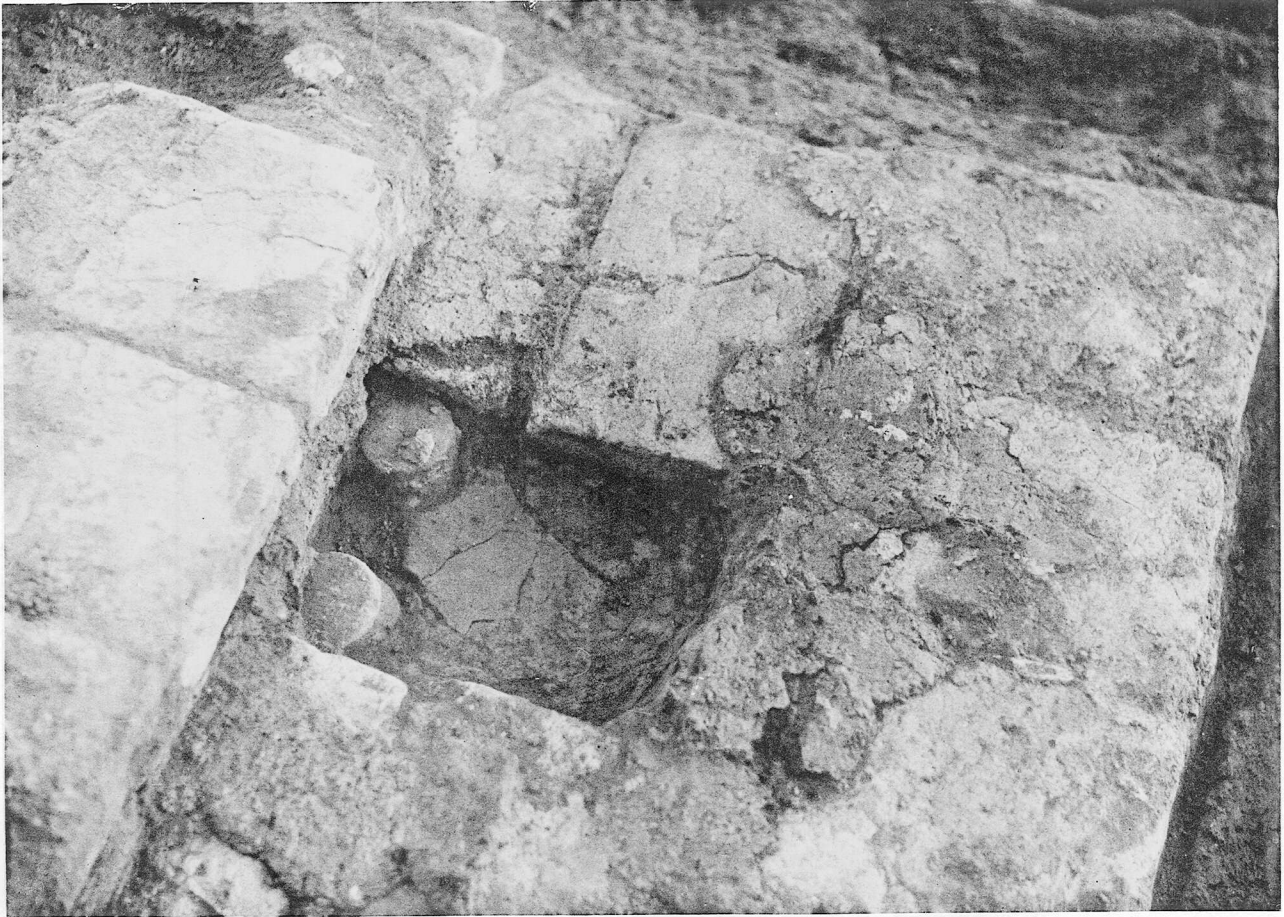
a. North corner building; foundation-box of Nur-Adad with cylinders in position. (See p. 38)

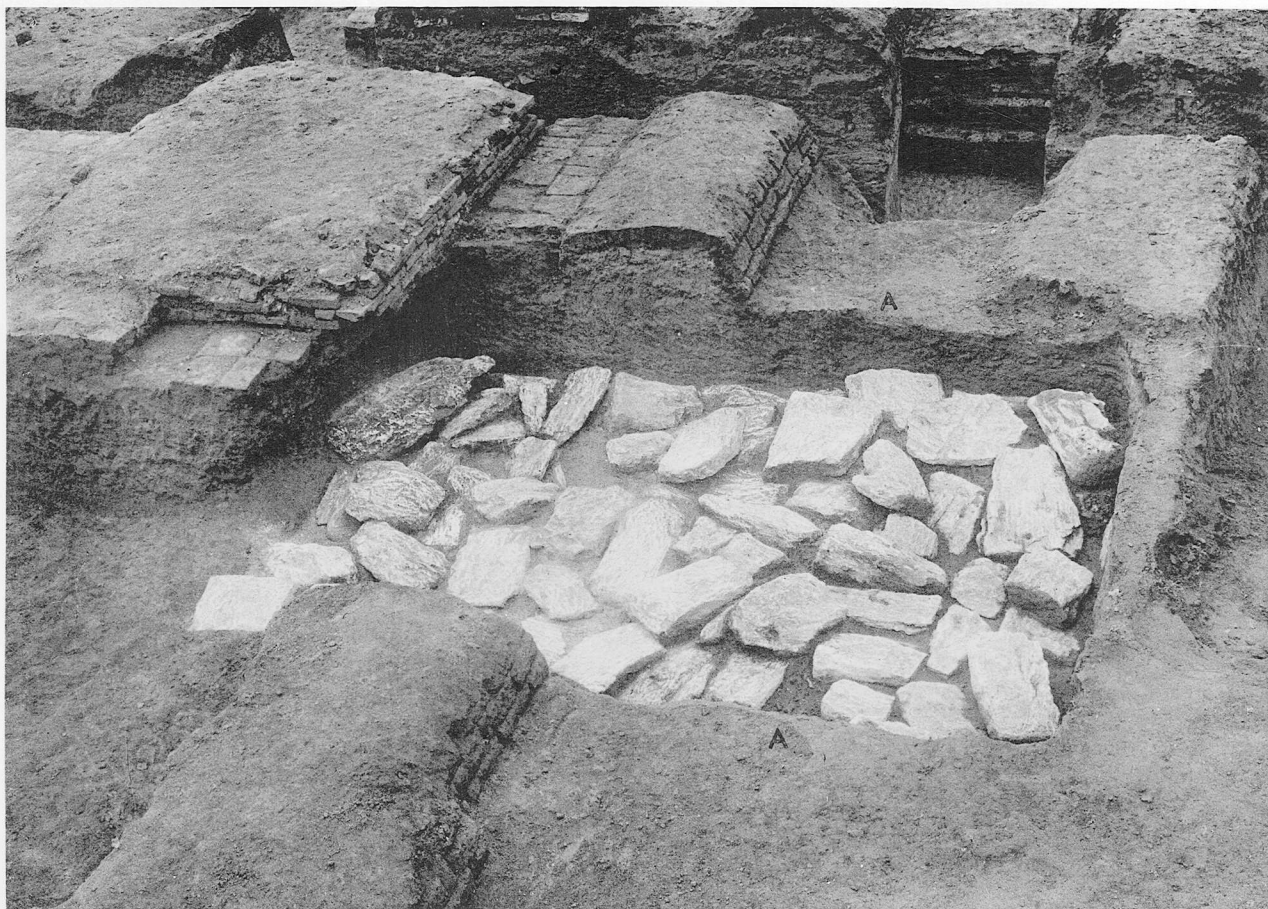
a. The stone-filled altar-foundation: A, A, Ur-Nammu floor; B . . . B, wall of Second Dynasty (?); above, remains of the Nabonidus 'Boat Shrine', c, c. (See p. 34)

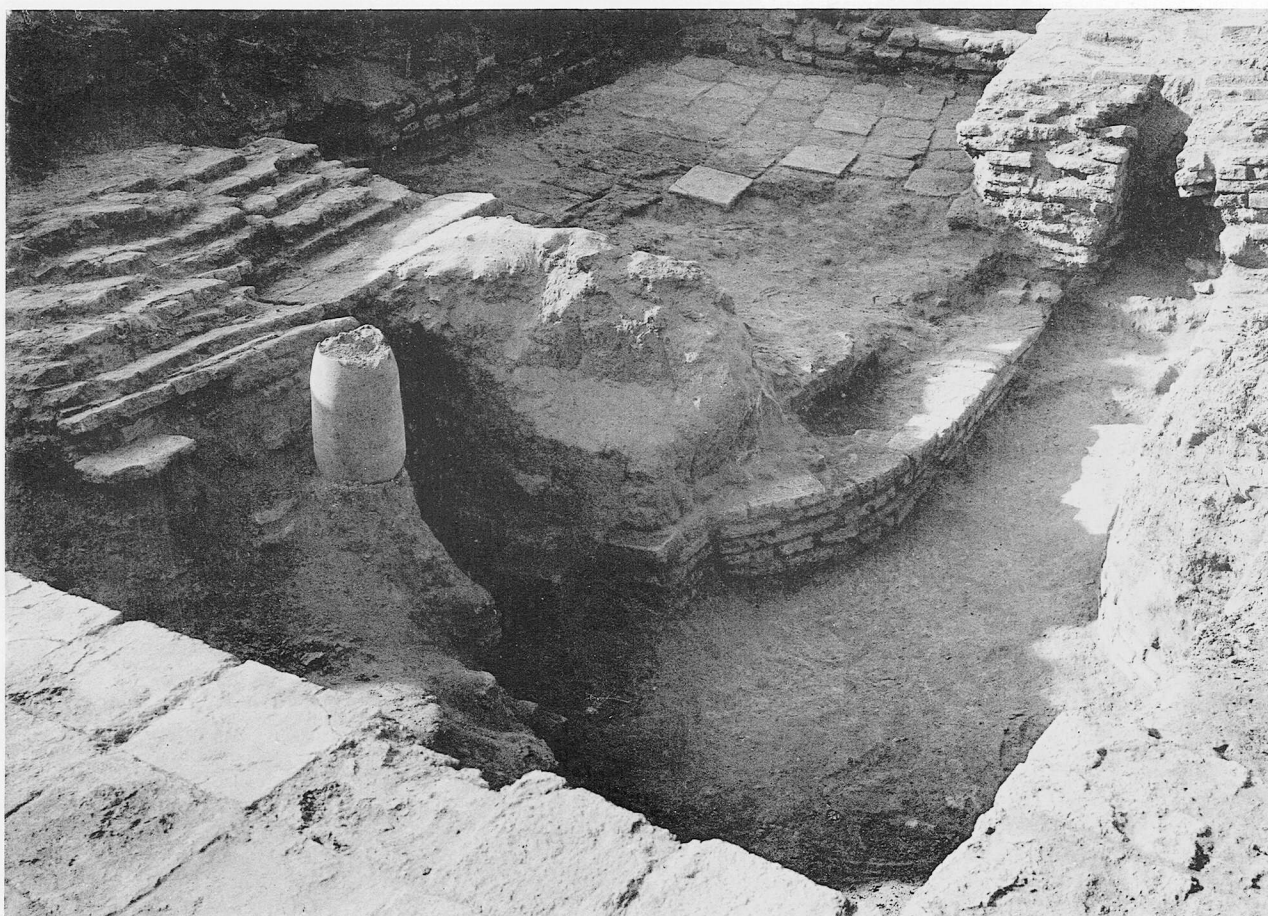
b. The drain of Ur-Nammu running through the SW. terrace wall. (See p. 29)

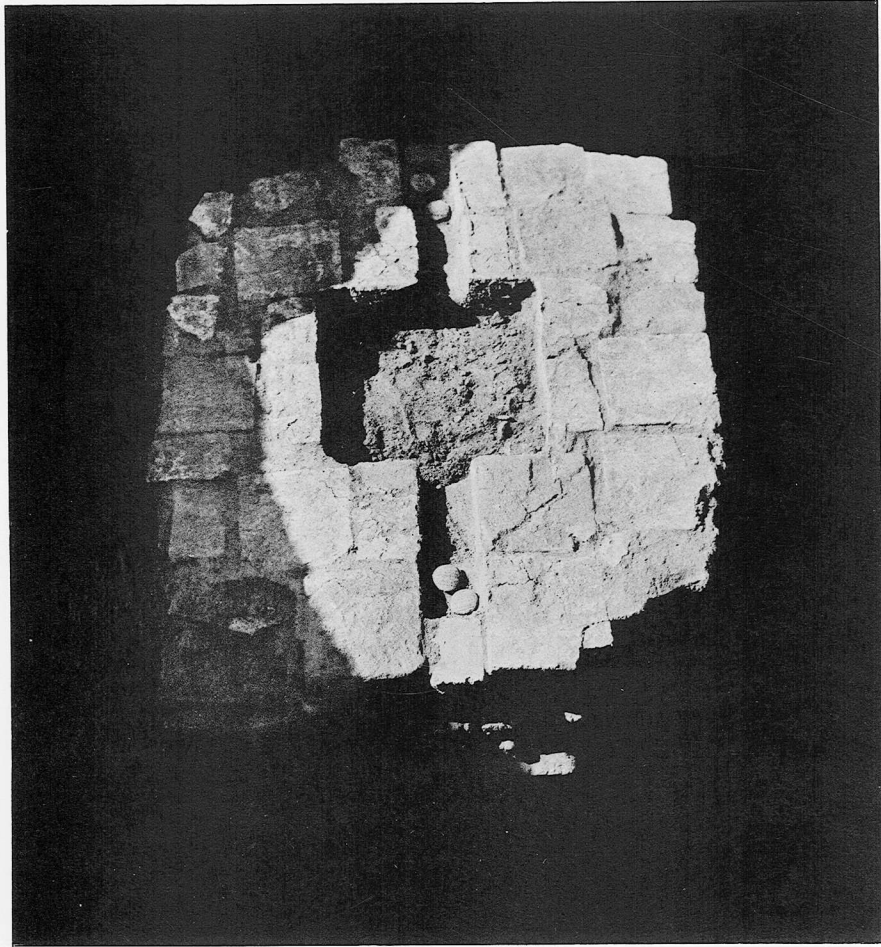
a. The Nin-gal well: upper courses of brickwork removed, showing foundation-tablets. (See p. 33)

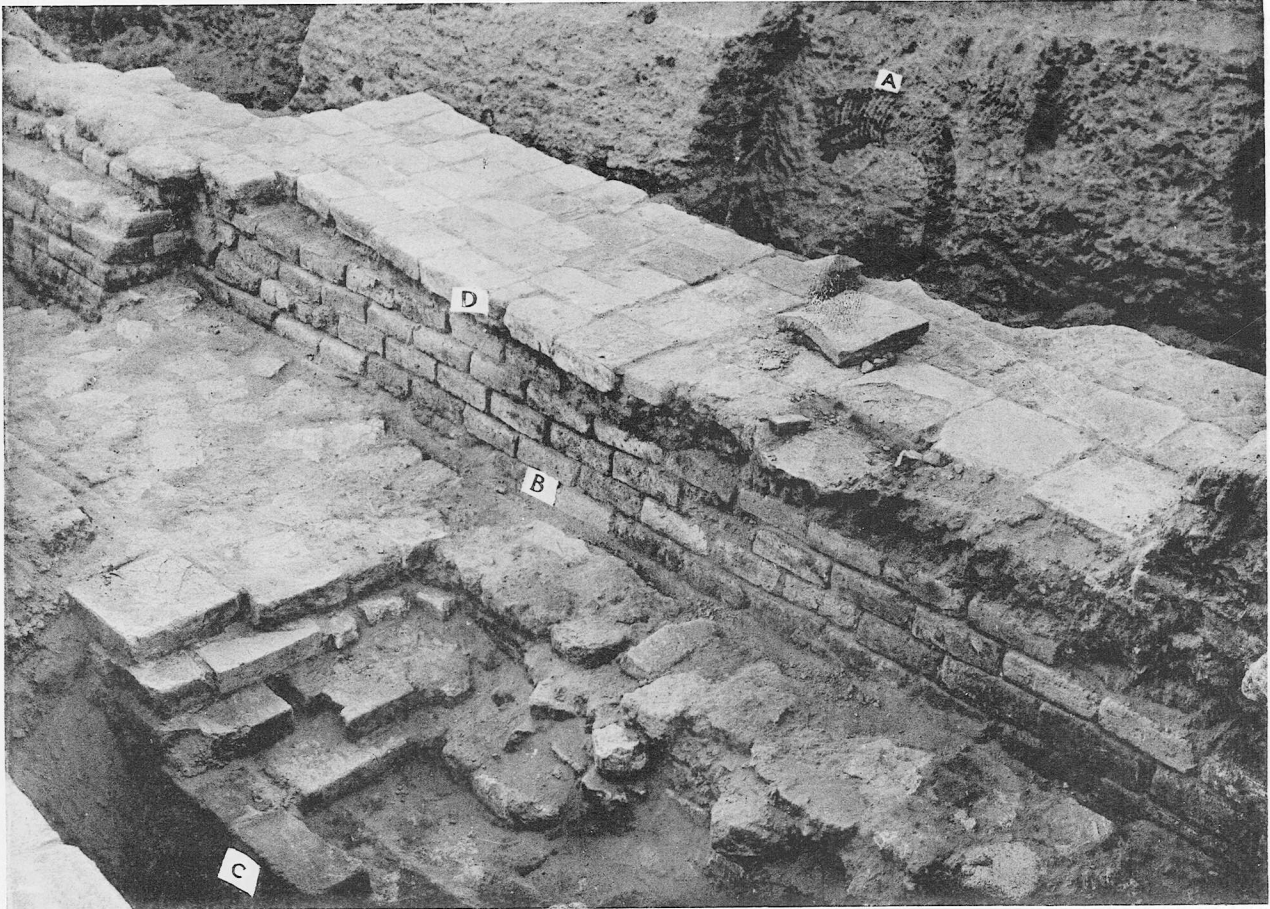
a. The NW. retaining-wall: A, mud-brick wall of Ur-Nammu; B, Larsa revetment; c, revetment of Kuri-Galzu; D, pavement of Sin-balatsu-iqbi (?). (See pp. 40, 49)
