UR EXCAVATIONS

VOLUME V

THE ZIGGURAT AND ITS
SURROUNDINGS

SIR LEONARD WOOLLEY

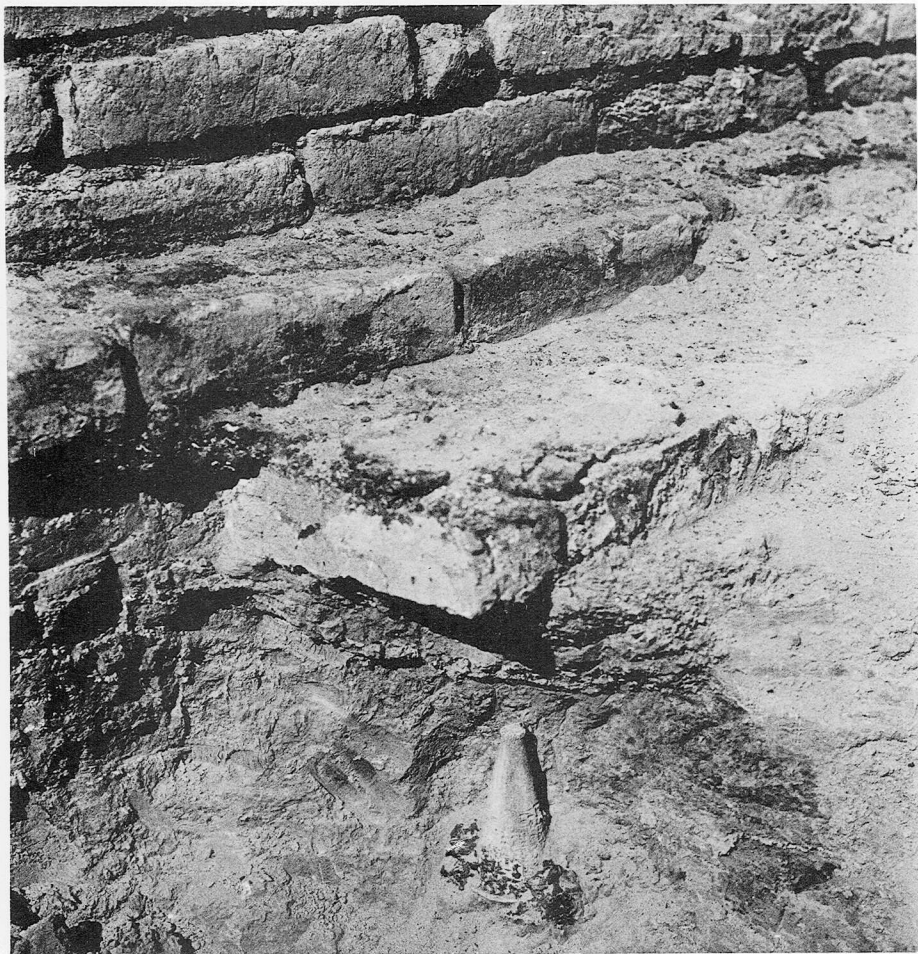
b. The Nin-gal Temple: foundation-cones of Sin-balatsu-iqbi in position. (*See p. 63*)

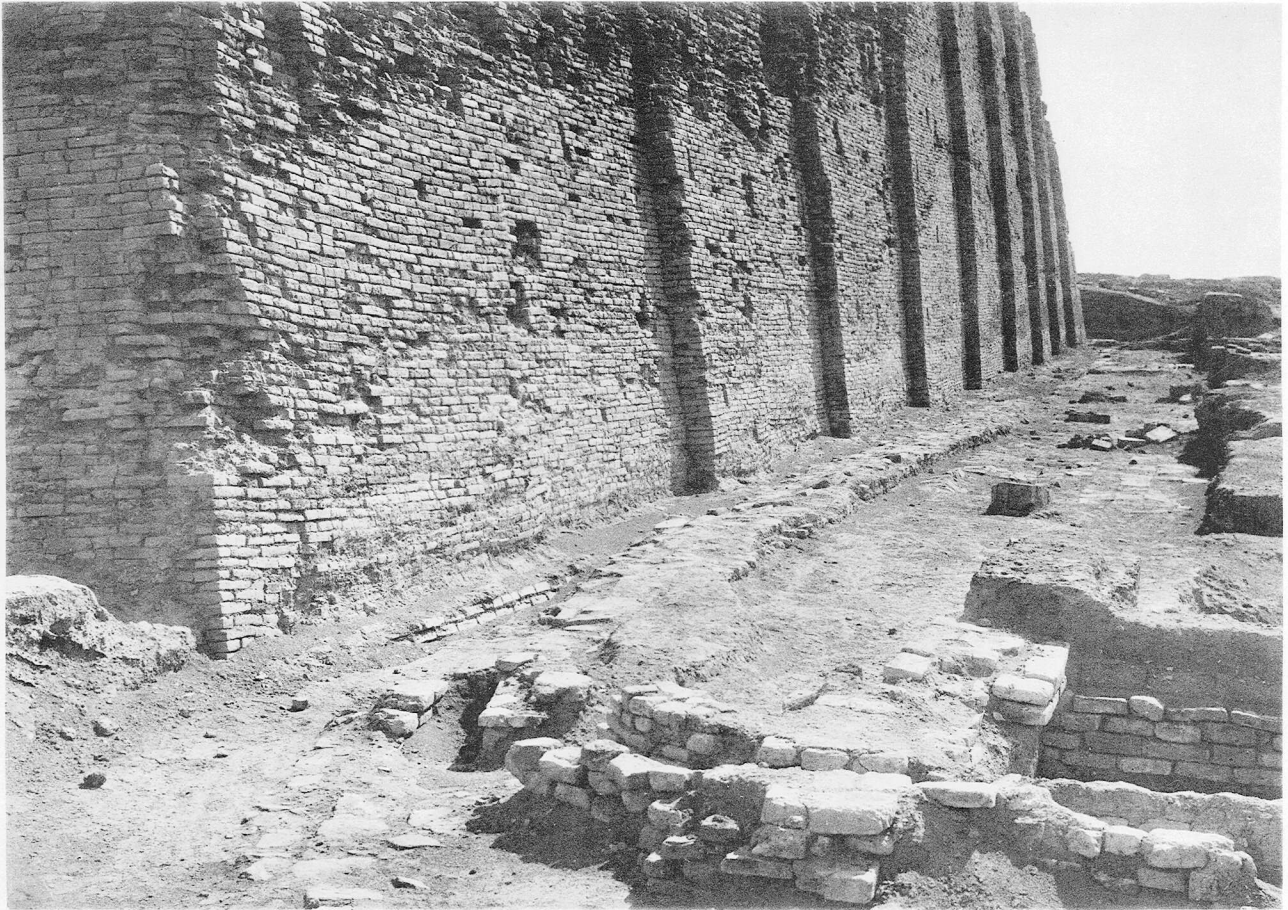
a. The SW. side, showing Kassite drains and wall-remains. (*See p. 53*)

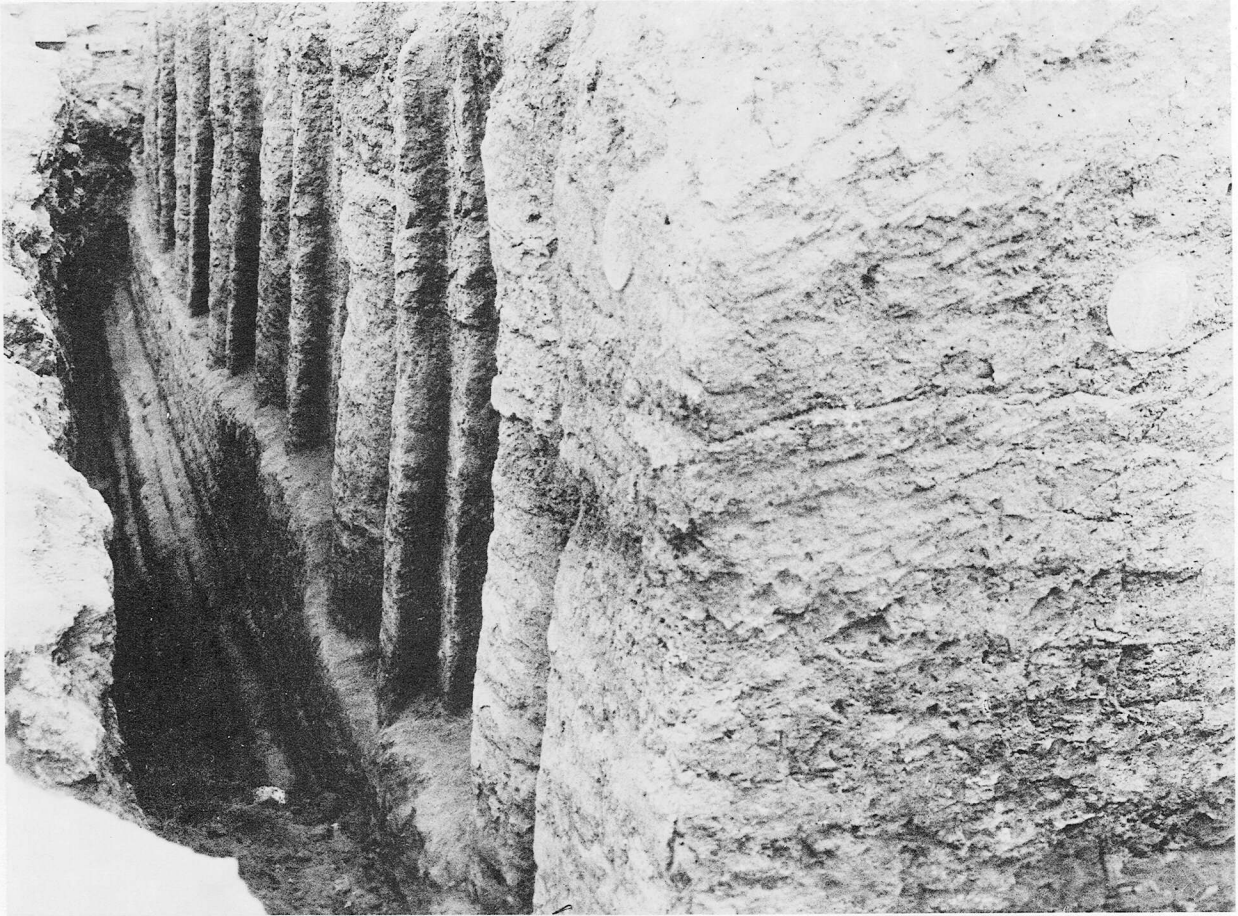
a. The bastion of Warad-Sin, showing foundation-cones in position in the wall. (*See p. 43*)

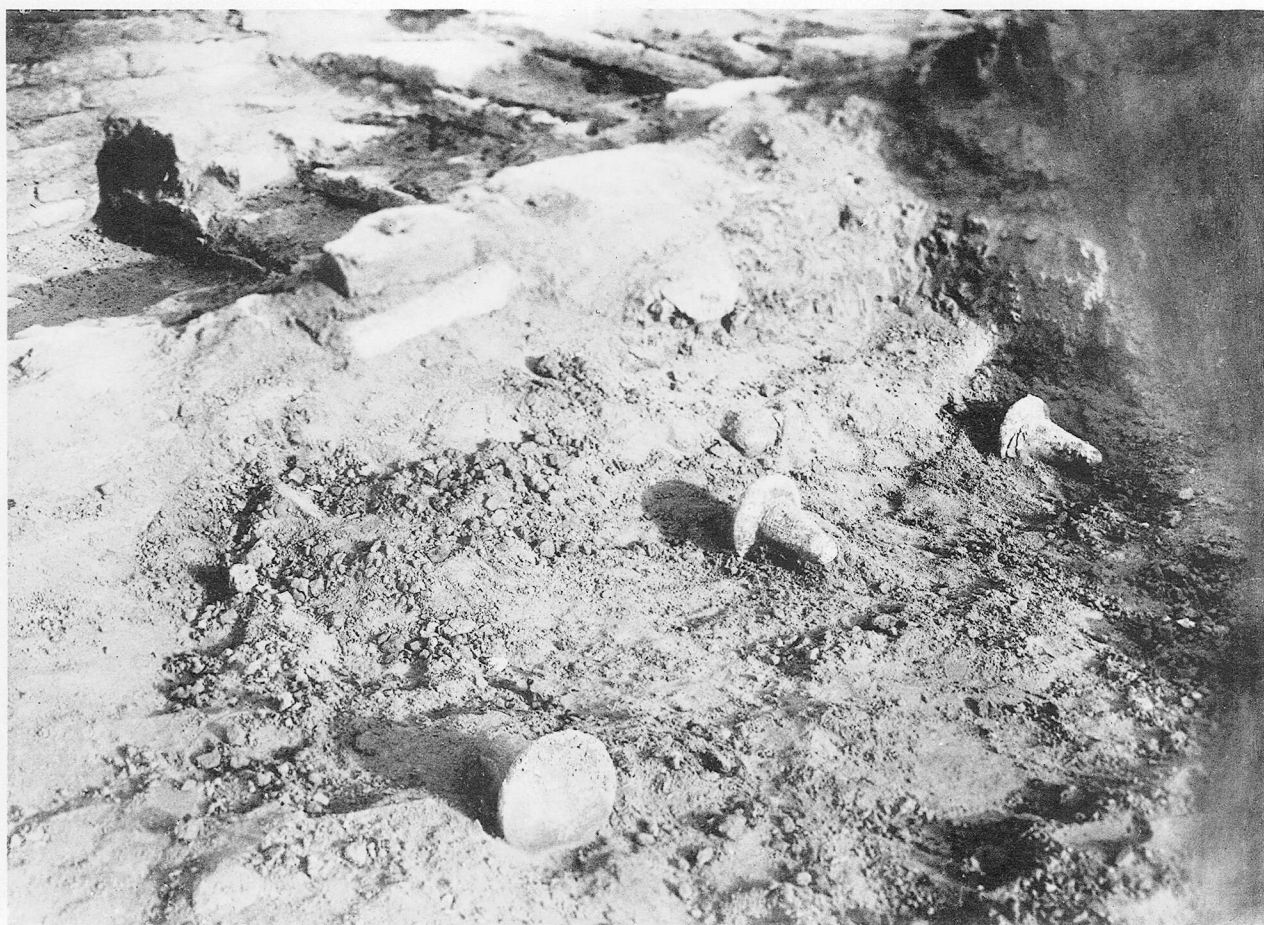
b. The Warad-Sin Bastion: foundation-cones *in situ* in the core of the wall. (See p. 43)

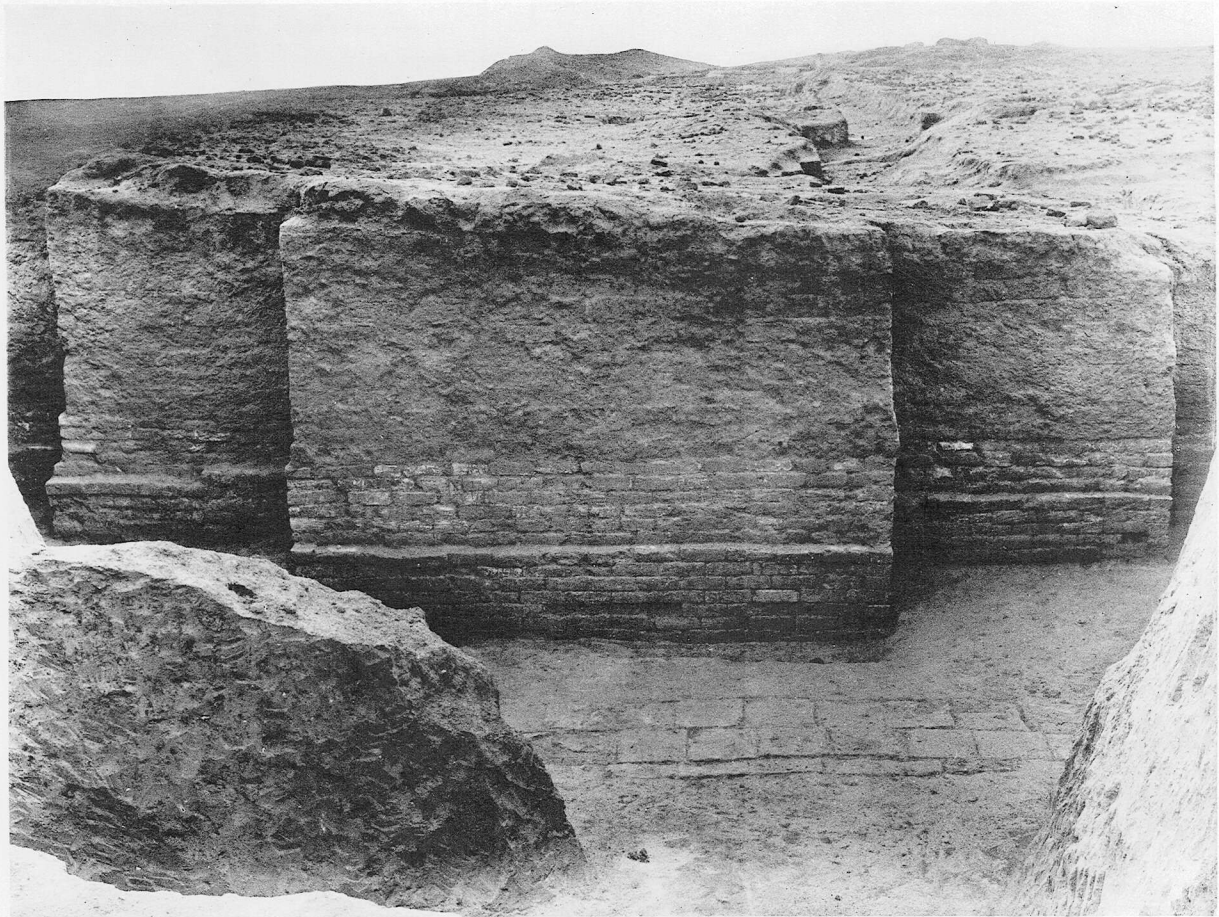
a. The NW. retaining-wall of the Nannar courtyard built by Kuri-Galzu: outer face. (See p. 88)

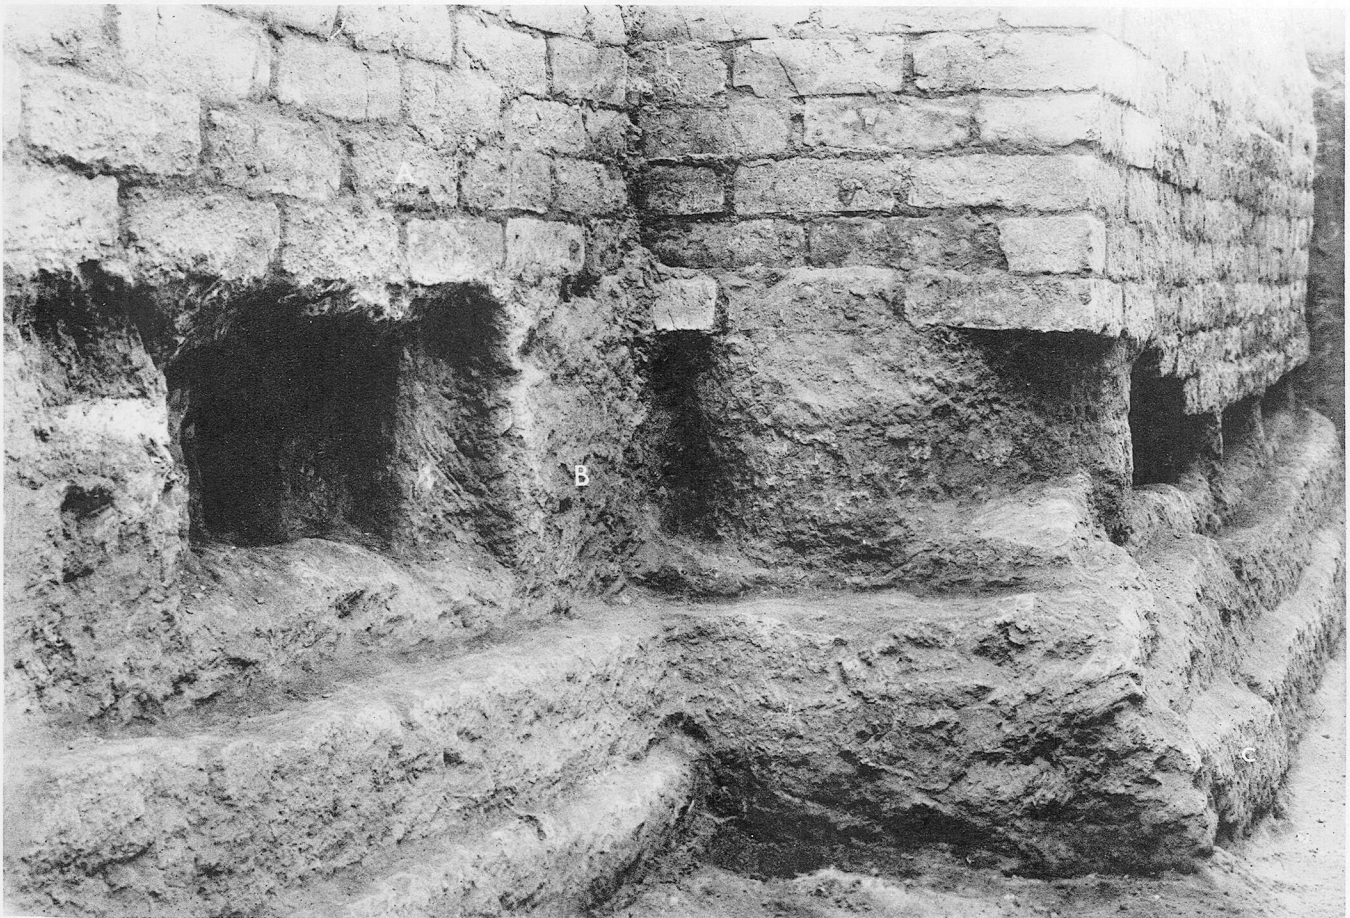
b. The E. corner of the Nannar courtyard: the outer wall-face showing: A, the burnt-brickwork of Kuri-Galzu; B, the half-column construction of Warad-Sin; and C, earlier foundations. (See p. 82)

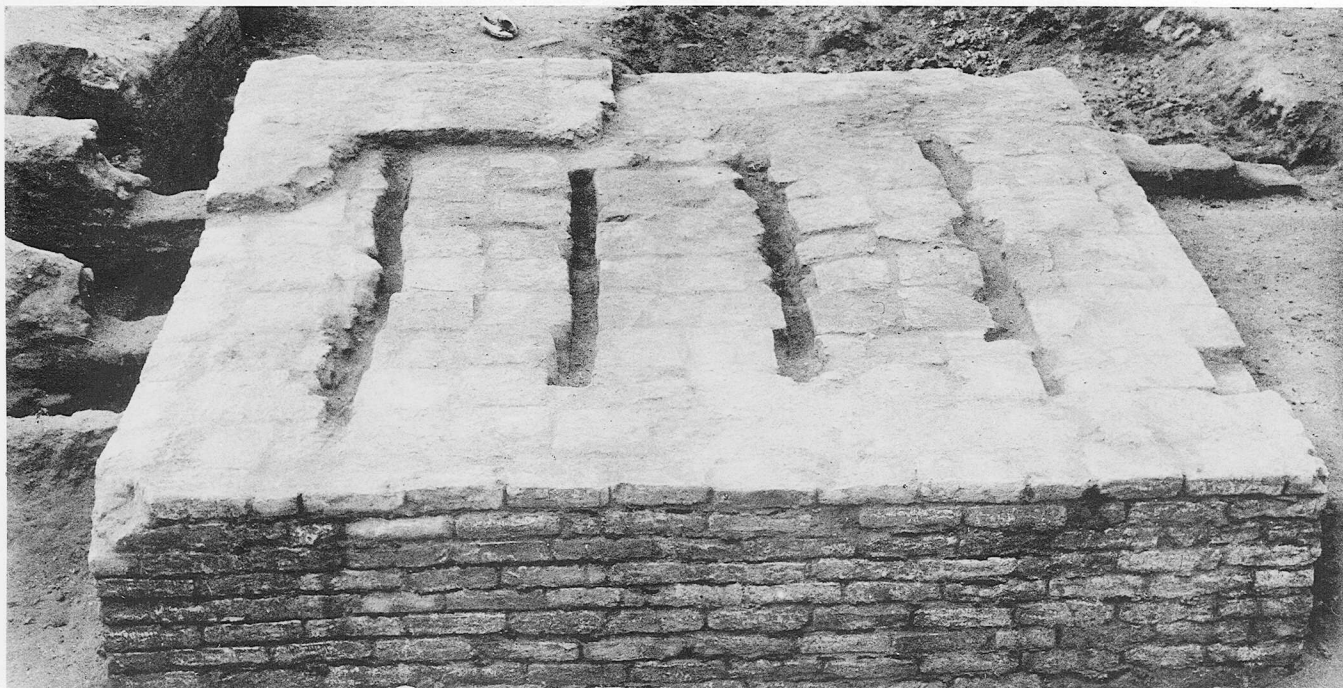
a. The Sin-idinnam base, top view. (See p. 83)

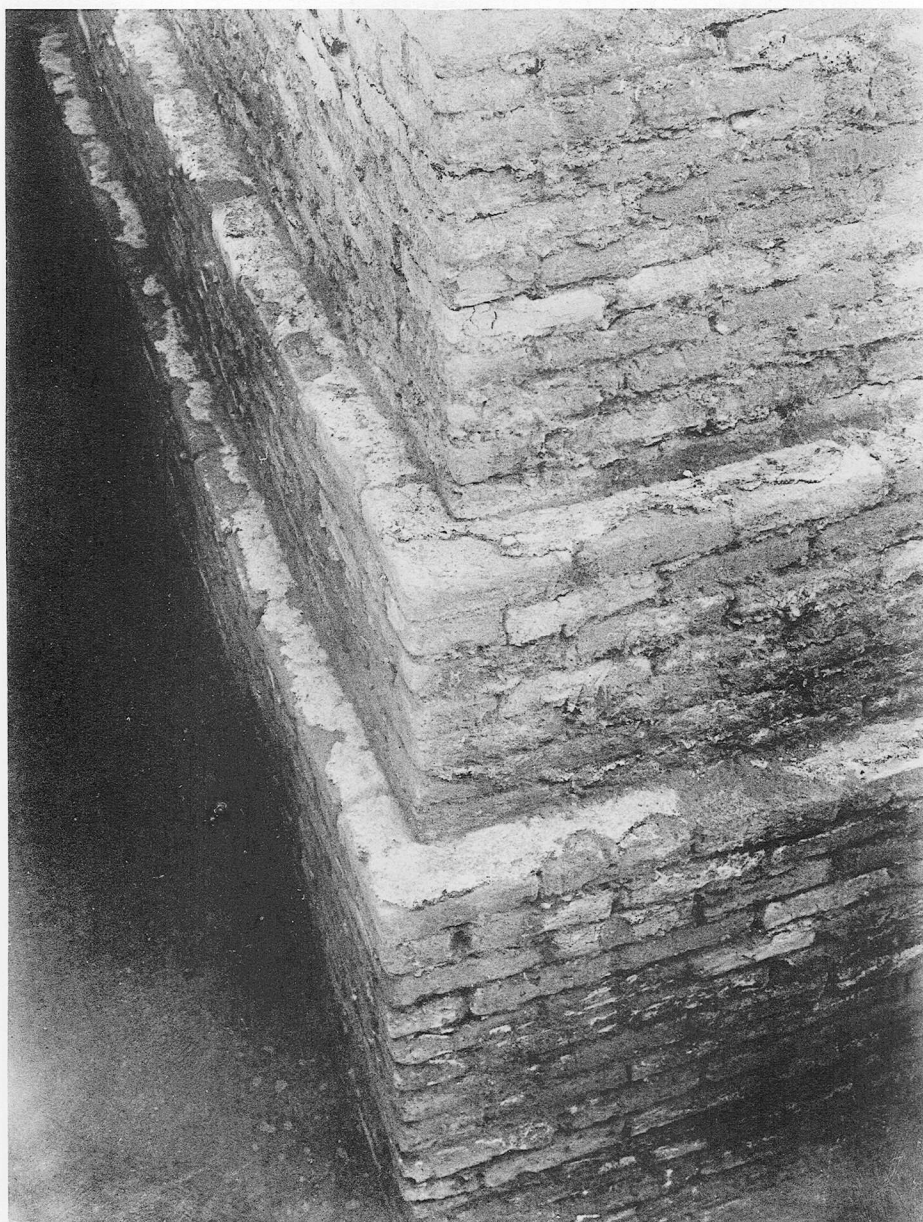
b. The same, showing stepped-out foundations. (See p. 83)

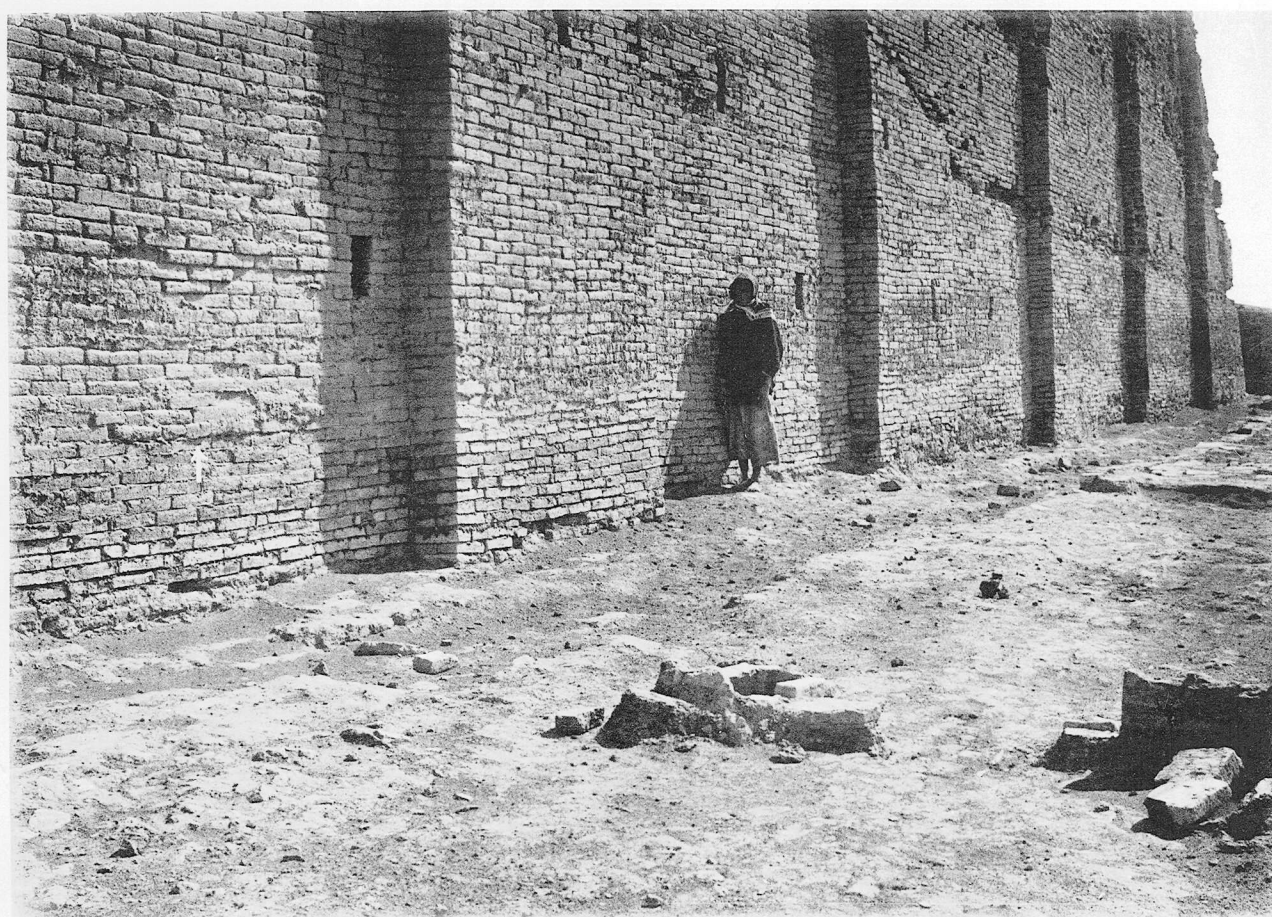
a. The SW. face: the brickwork in the first bay was repaired in Larsa times (stamped brick of Bur-Sin found here). (*See pp. 73, 122*)

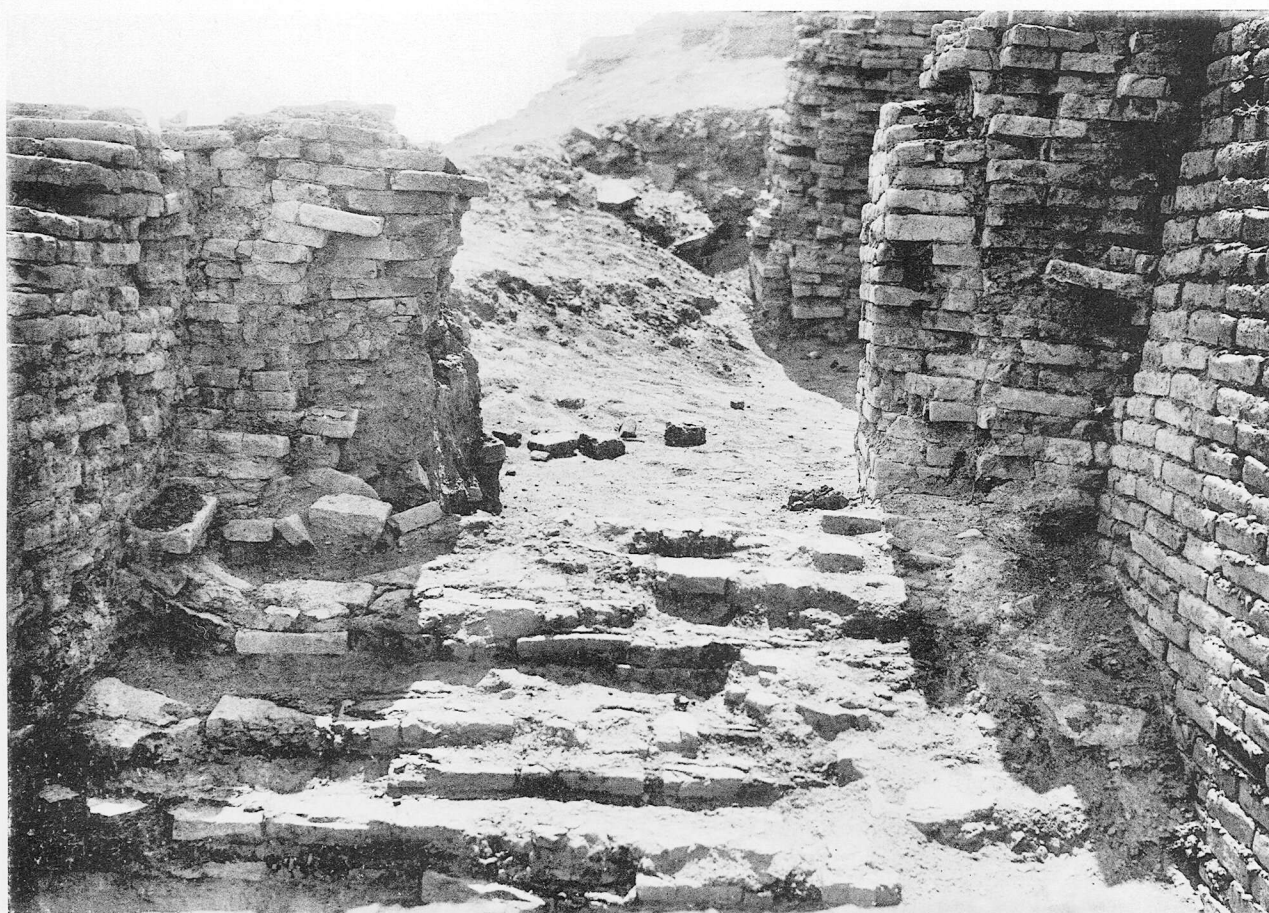
b. Top of NW. flight of stairs, showing the remaining treads of Ur-Nammu's stairway and the doorway of the platform tower. (*See p. 101*)

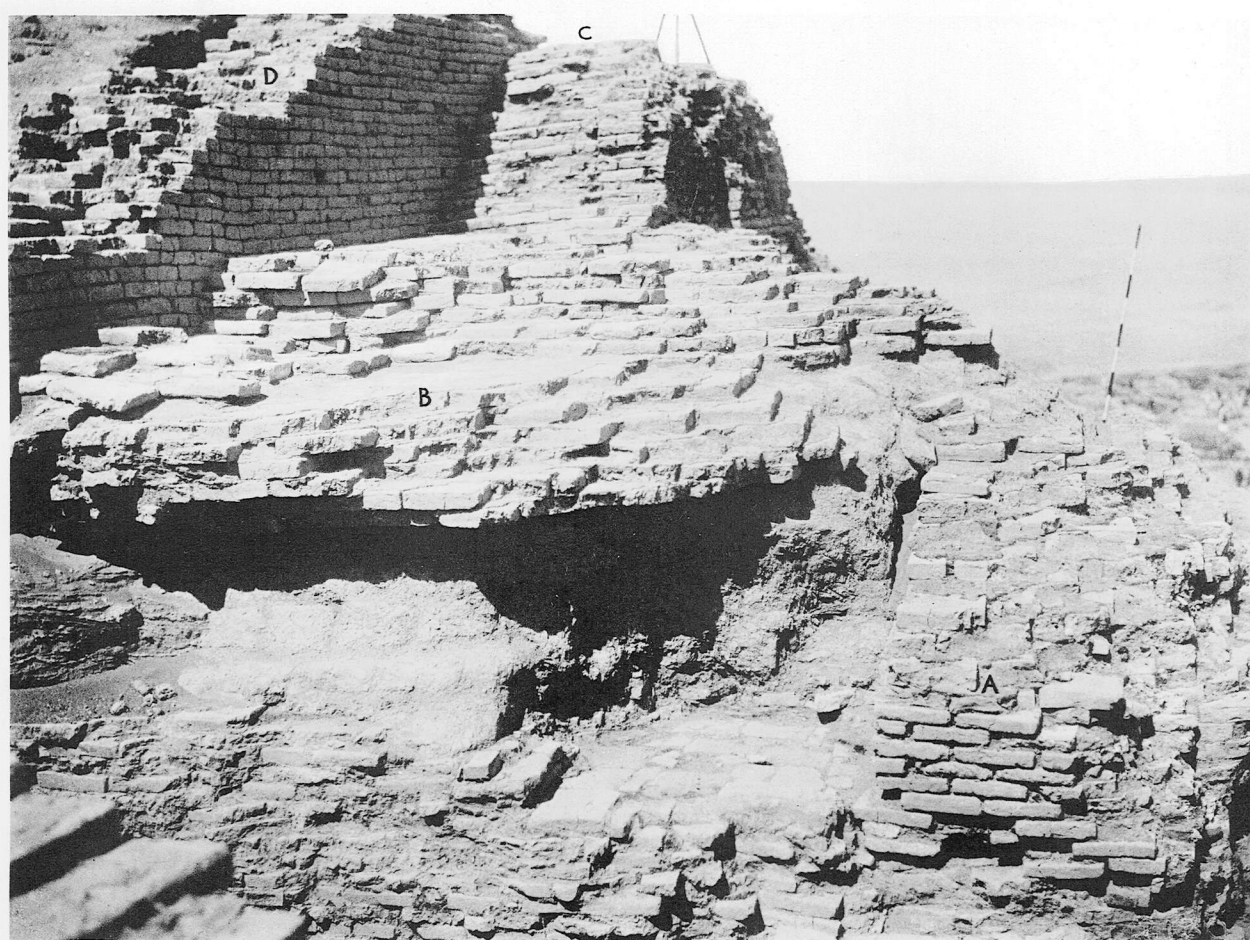
b. The NE. terrace: A, foundations of Ur-Nammu's gate tower and jamb of his entrance to upper flight; B, the Ur-Nammu pavement, repaired by Nabonidus; C, Nabonidus' staircase; D, terrace wall of Ur-Nammu, repaired by Nabonidus

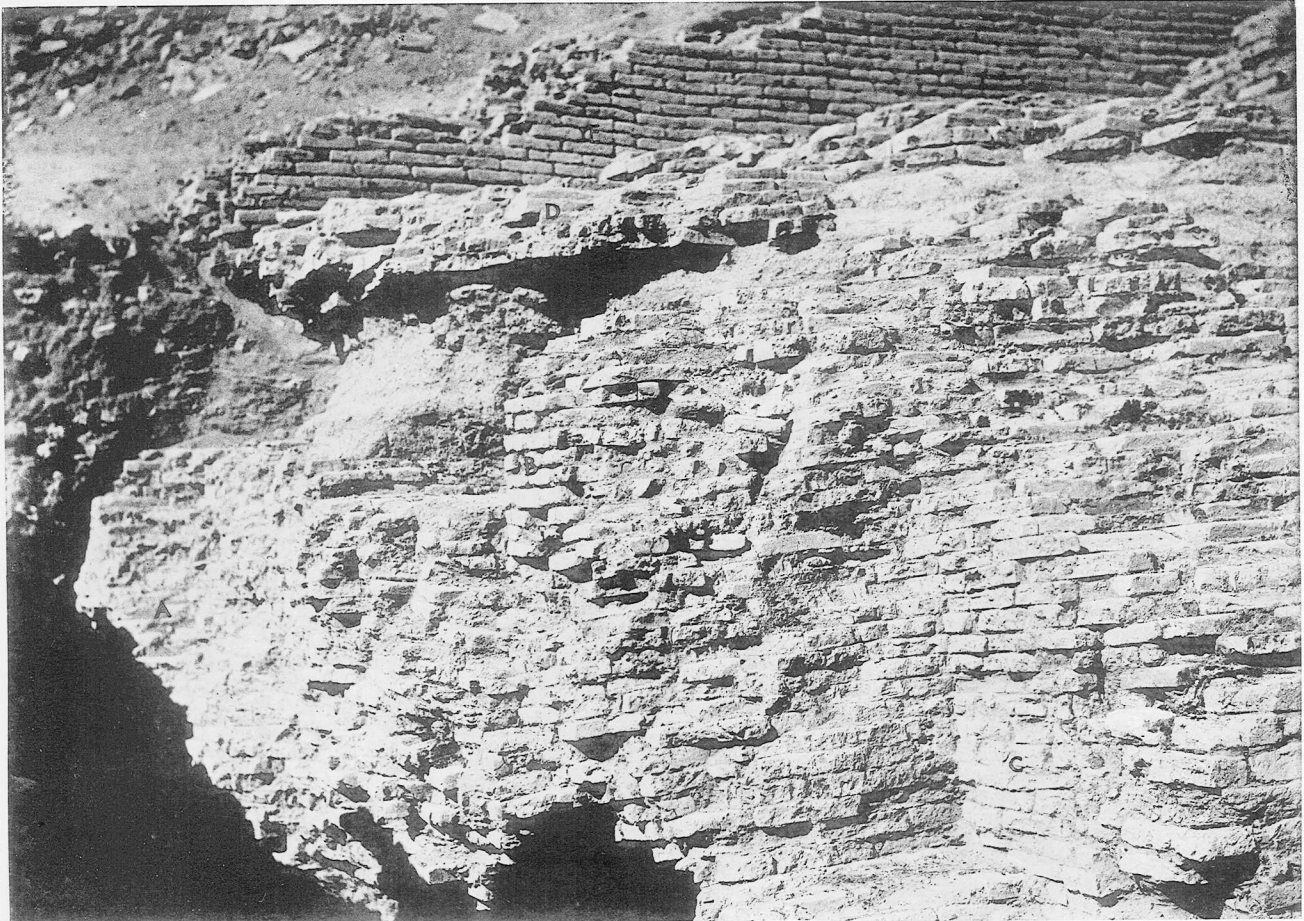
a. NW. section of Taylor's cut, showing: A, the section of the upper stair-foundation of Ur-Nammu; B, jamb of door to Ur-Nammu's upper flight; C, inner face of gateway jamb on NW. lower flight of Ur-Nammu; D, E, pavement and wall of Nabonidus

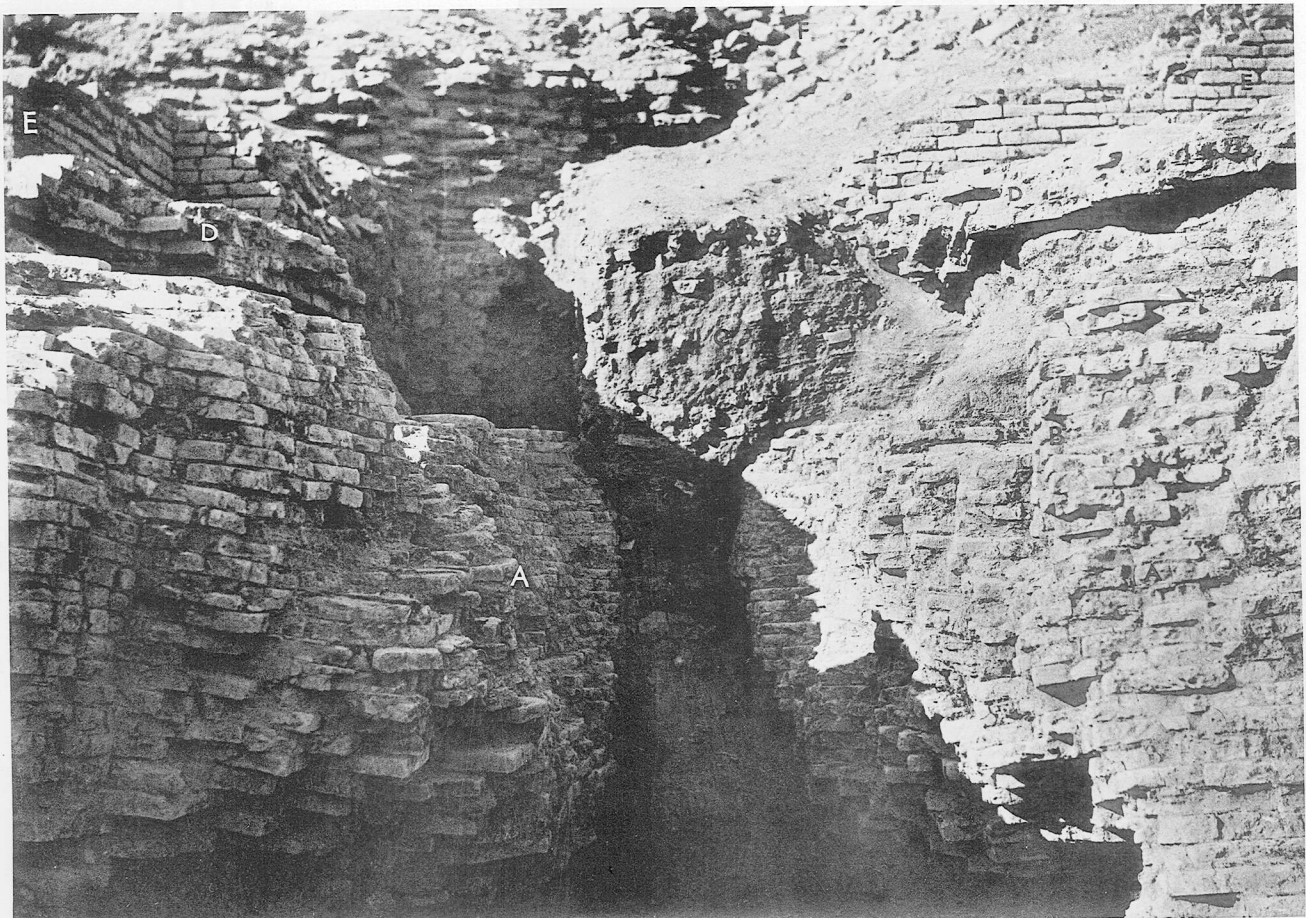
b. Taylor's cut, looking SW., showing: A, A, foundations of Ur-Nammu's upper stairs; B, face of jamb at stair-foot; C, rubbish filling left by Taylor; D, D, Nabonidus' terrace pavement; E, E, Nabonidus' terrace front; F, Nabonidus' mud-brick upper core

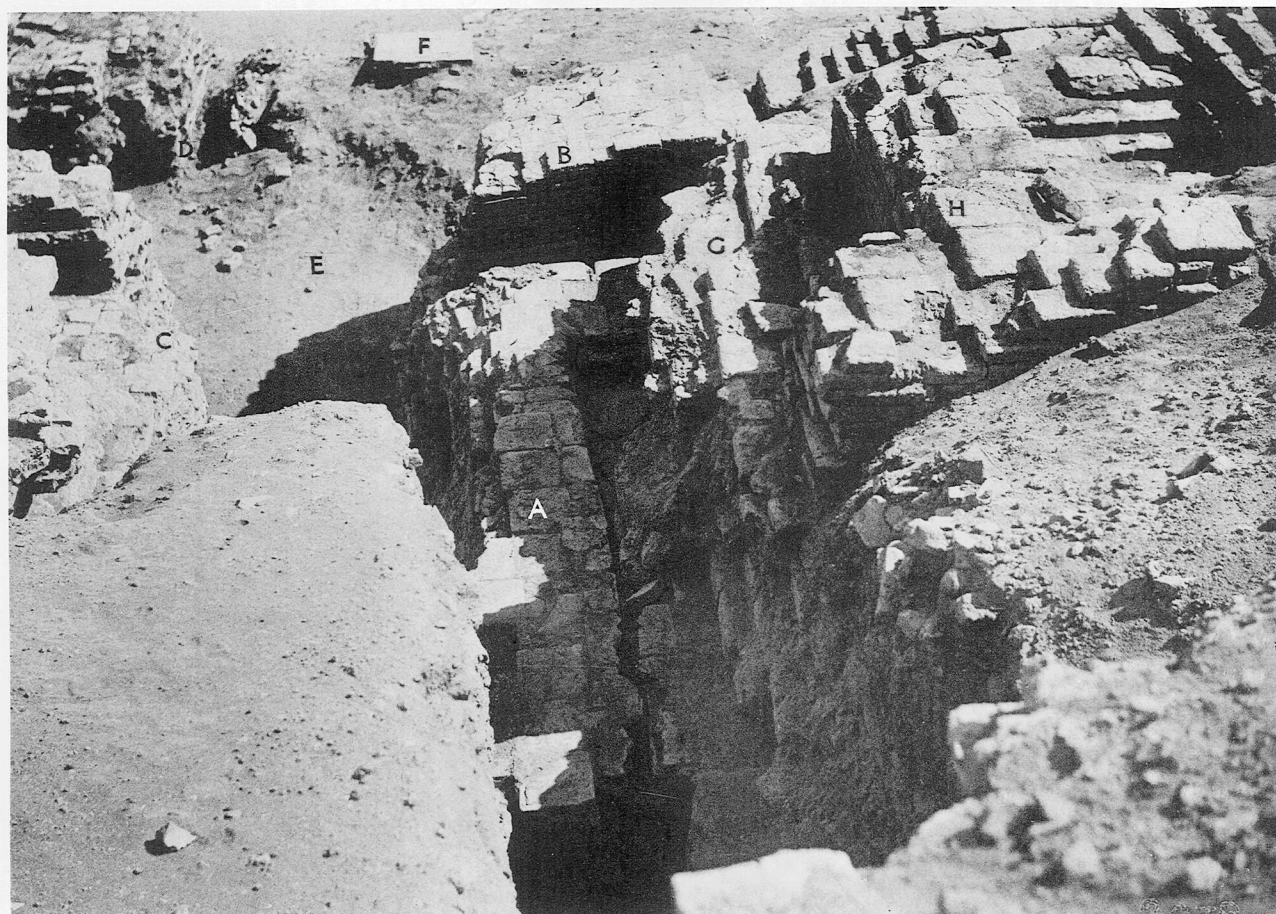
a. Taylor's cut: view looking NE.: A, side wall (SE. side) of upper Ur-Nammu staircase; B, foundation of S. corner of Ur-Nammu's gate-tower; C, W. corner of gate-tower; D, N. corner of gate-tower; E, present level of Ur-Nammu's stair-head, main flight; F, modern stair-head; G, Nabonidus pavement; H, Nabonidus terrace wall

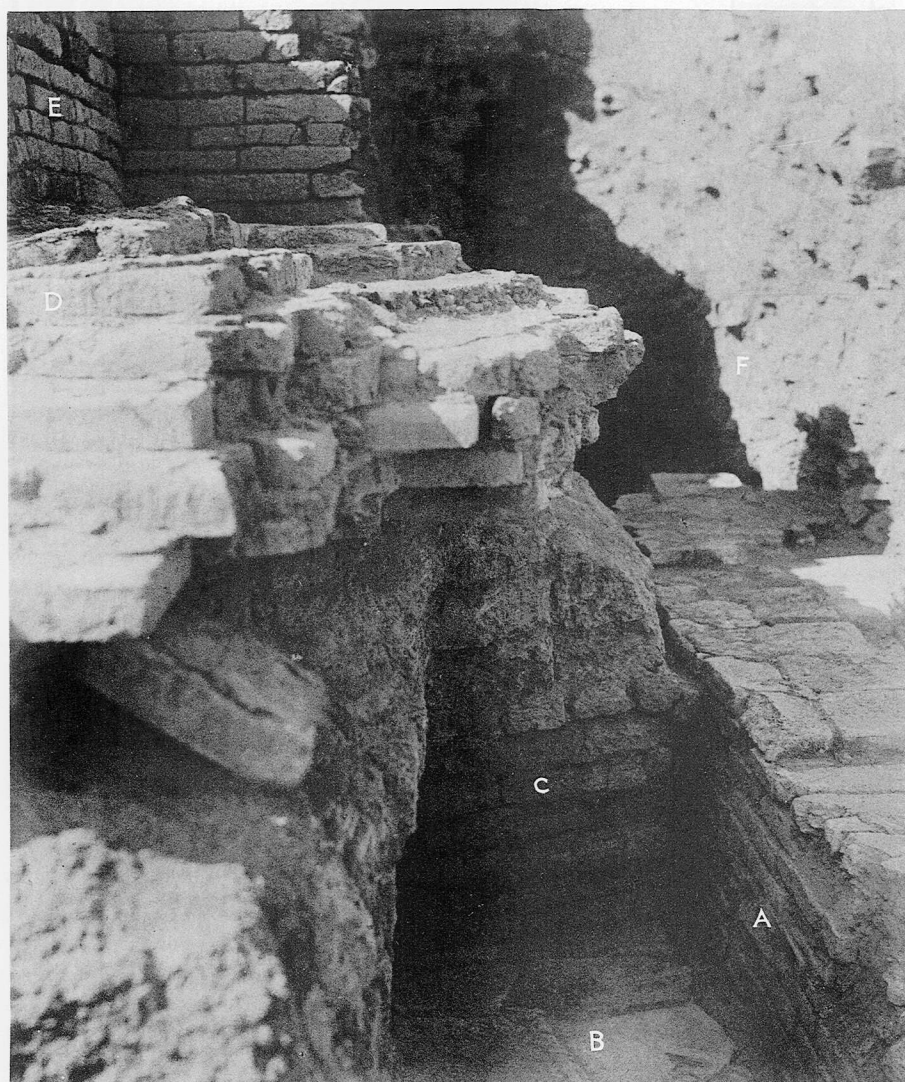
b. The same: the approach to Ur-Nammu's second staircase: A, battered containing-wall of second flight; B, foundation-chamber (?) with later pavement; C, later (Larsa?) wall; D, terrace pavement of Nabonidus; E, upper terrace wall of Nabonidus; F, tunnel cut by Taylor. (See p. 106)

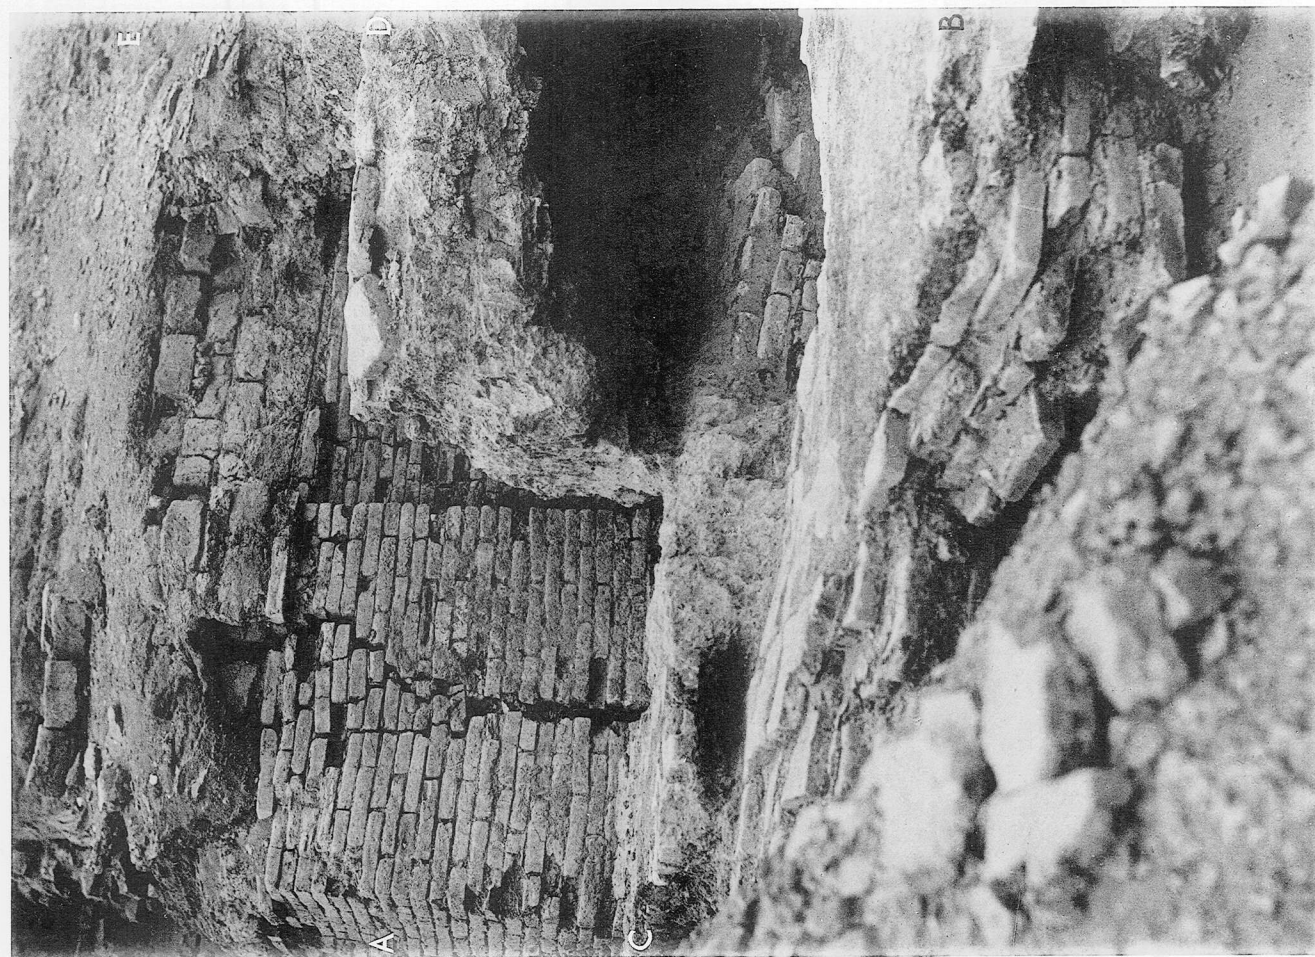
a. S. angle of upper terrace: A, S. corner of Ur-Nammu's upper terrace wall; B, Ur-Nammu's lower terrace pavement; C, Larsa pavement; D, burnt-brick pavement resting on cement foundations; E, mud-brickwork of Nabonidus

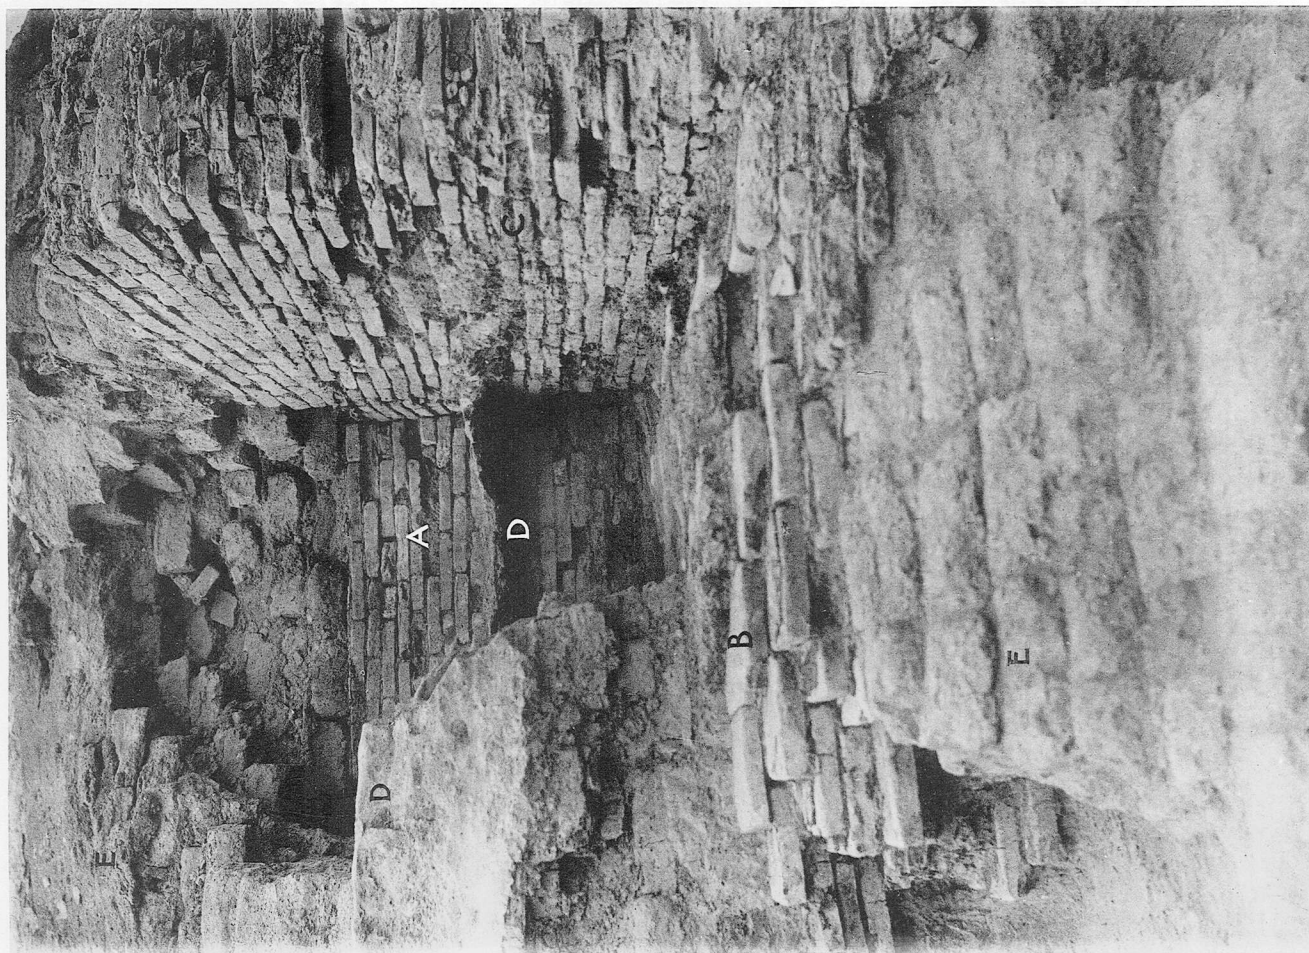
b. The same: A, buttressed wall of Ur-Nammu's upper terrace; B, Ur-Nammu's pavement; C, cross-wall of Ur-Nammu's terrace chamber, with later brickwork above; D, cement floor-foundation; E, Nabonidus brickwork. (See p. 123)

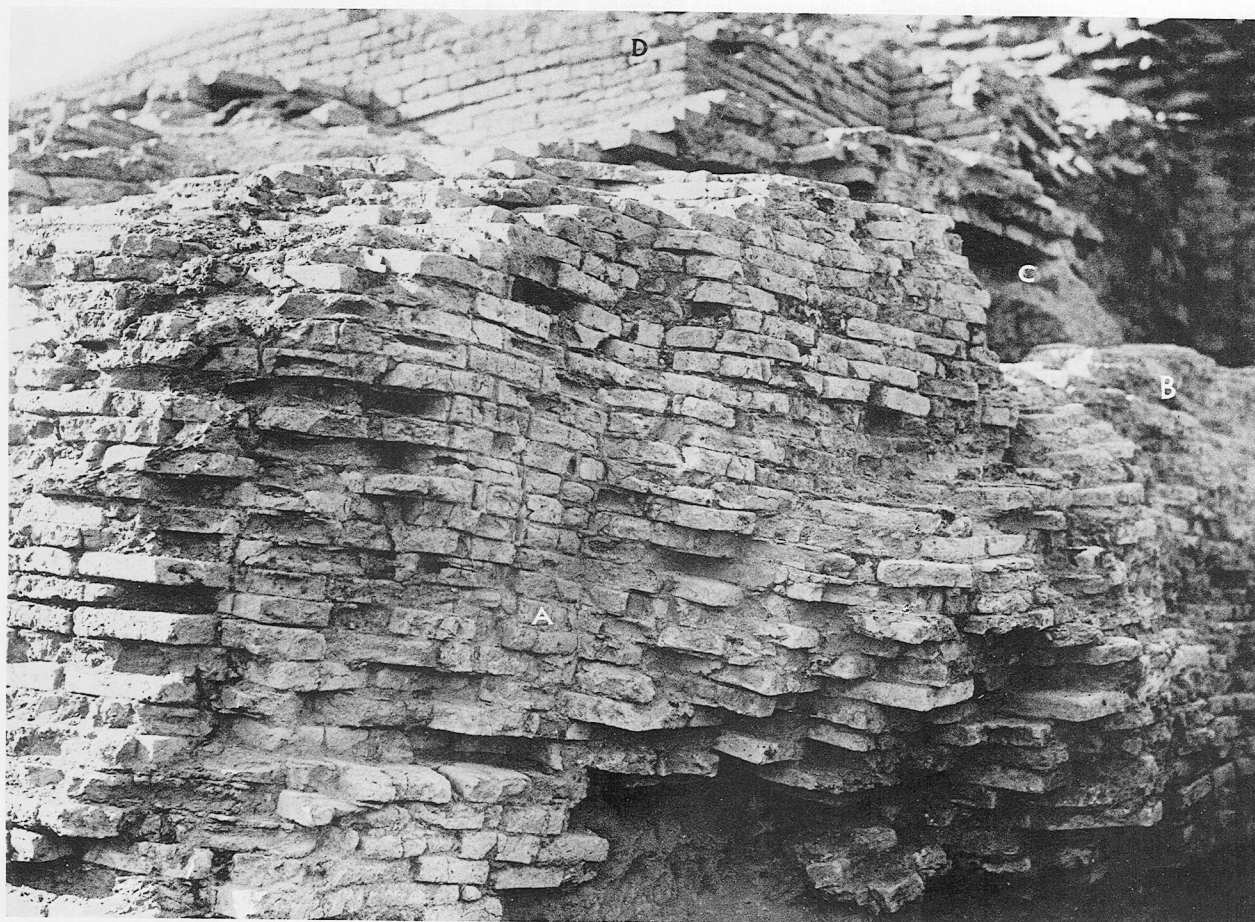
a. The SE. side of Taylor's cut, showing: *A*, brickwork of Ur-Nammu, the S. corner of the gate-tower; *B*, upper staircase wall of Ur-Nammu; *C*, pavement of Nabonidus; *D*, upper terrace front of Nabonidus

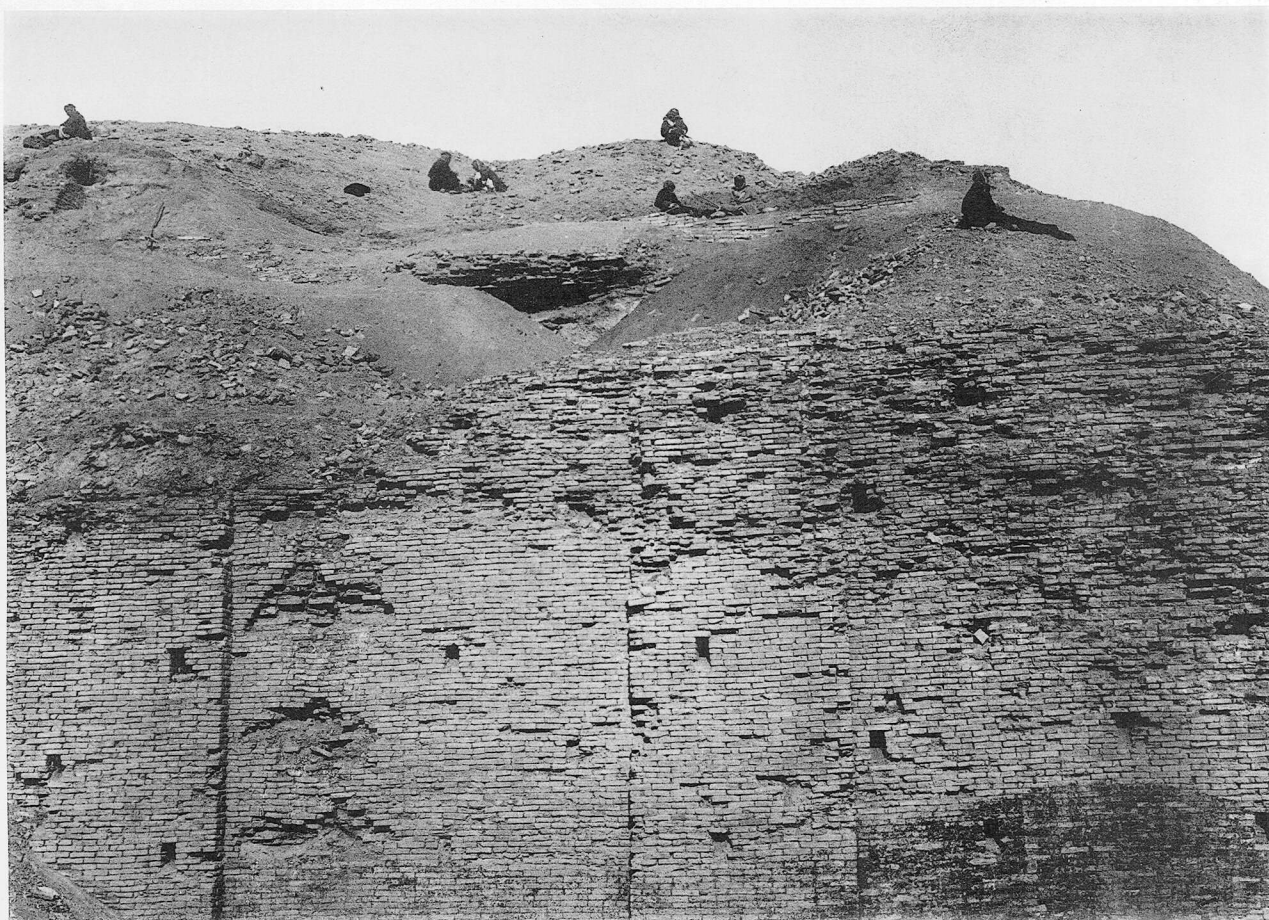
a. The SE. side of the Ziggurat, showing the broken pavement-edge of the terrace. (*See p. 129*)
