UR EXCAVATIONS

VOLUME V

THE ZIGGURAT AND ITS
SURROUNDINGS

SIR LEONARD WOOLLEY

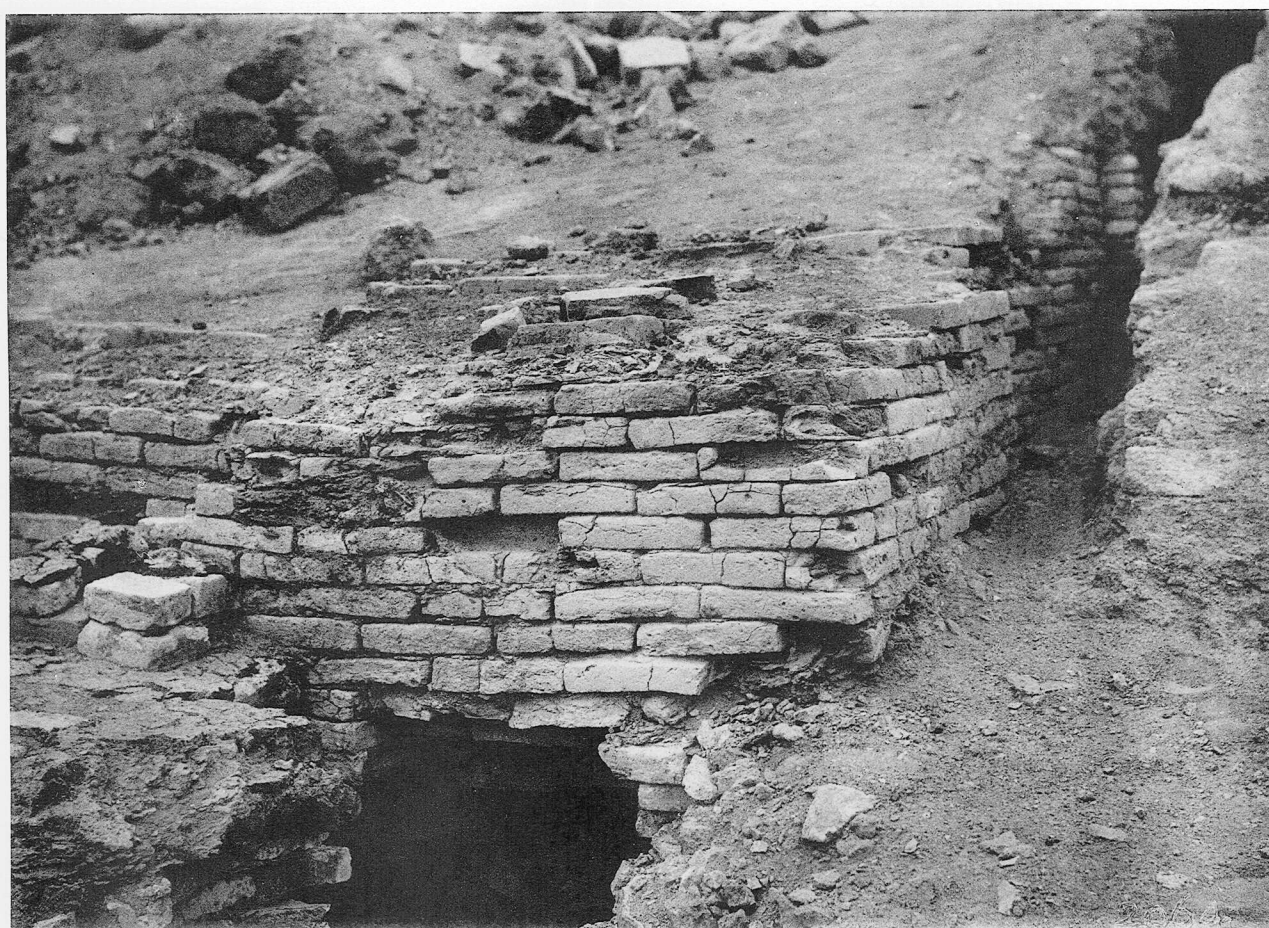
b. The E. corner of the upper terrace wall of Ur-Nammu, showing the hole in his pavement and wall-foundation made by Nabonidus (the hole then filled up with Nabonidus brickwork). (*See p. 129*)

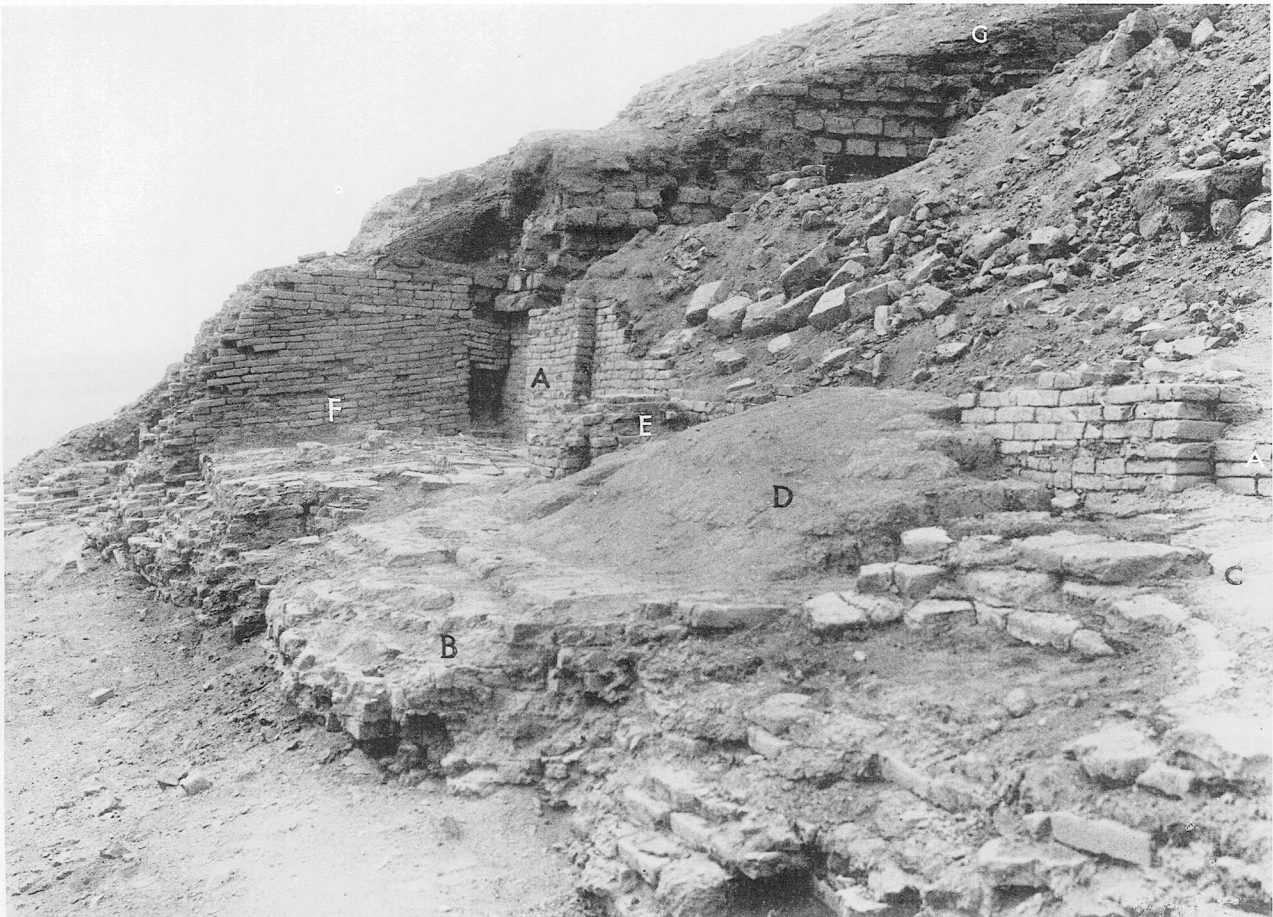
a. SE. front of upper terrace: A . . . A, Ur-Nammu's upper terrace wall; B, his pavement; c, Larsa wall; D, brickwork of Nabonidus; E, Ur-Nammu's first cross-wall with door reveal; F, Ur-Nammu's second cross-wall, with later brickwork above; G, Nabonidus' mud-brickwork. (See p. 109)

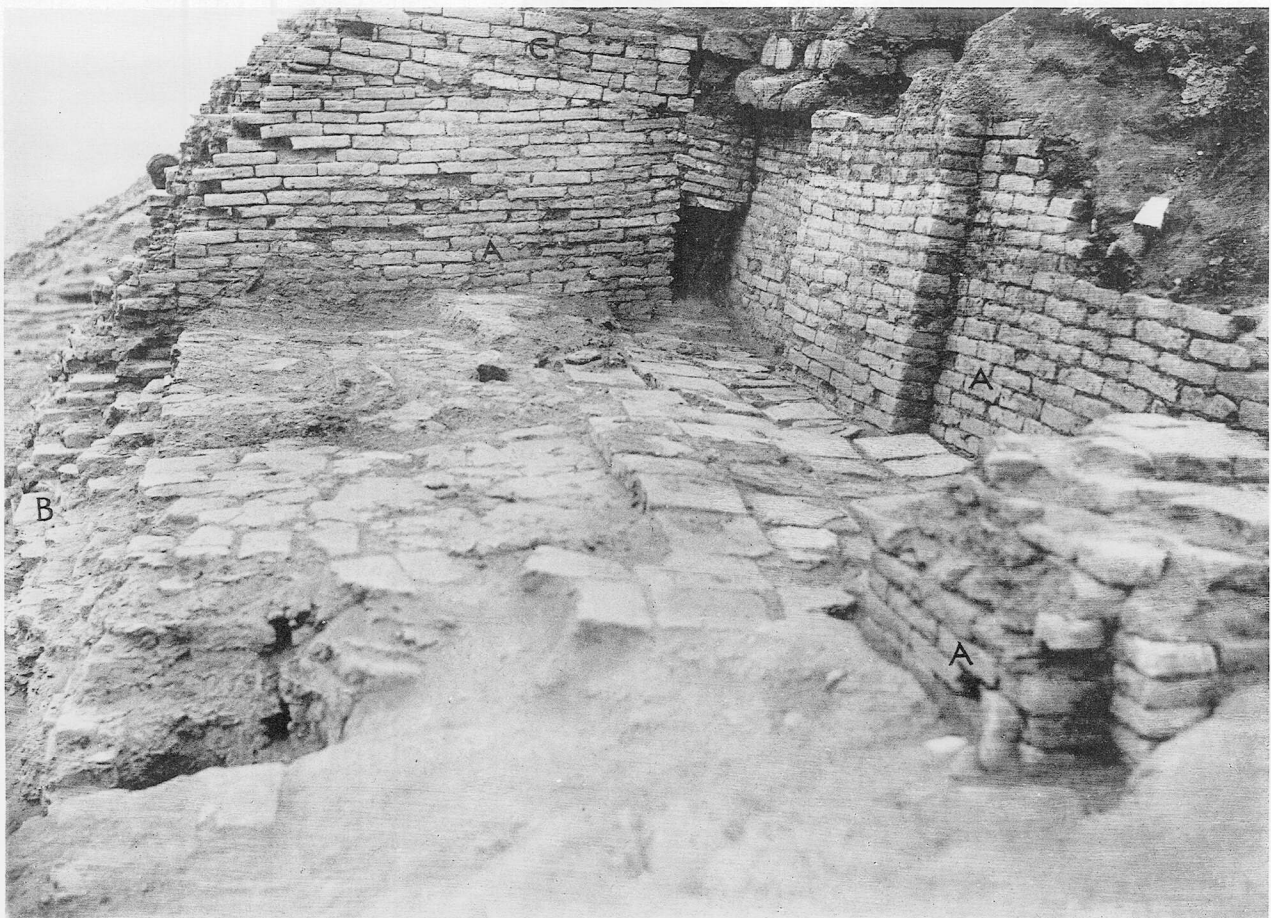
b. The terrace chamber: A, A, A, Ur-Nammu walls; B, Ur-Nammu wall-foundations; c, later brickwork. (See p. 110)

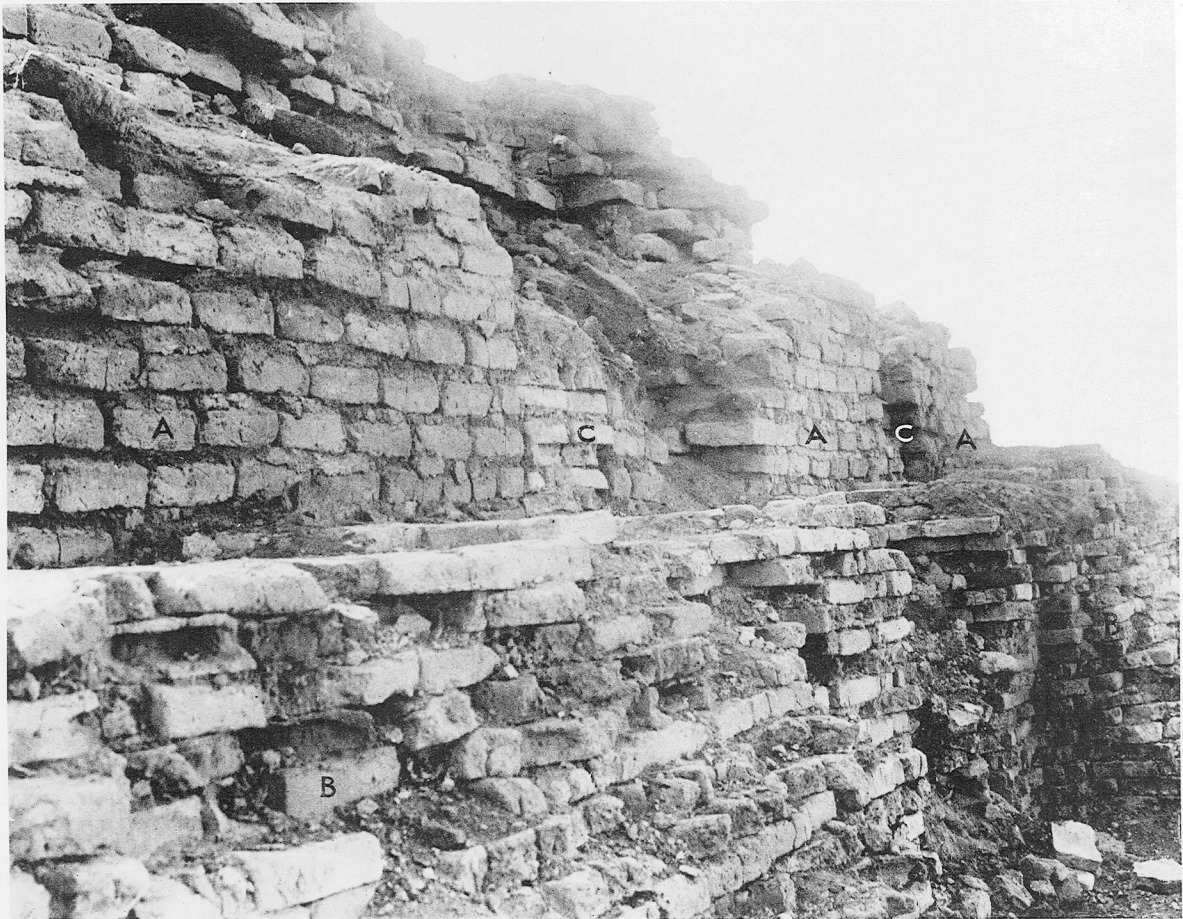
a. The NW. side of the Ziggurat, upper terrace: A . . . A, the crude brick core of the Nabonidus upper story; B . . . B, remains of burnt-brick casing; c, c, burnt-brick keys inset in the mud-brickwork. (See p. 127)

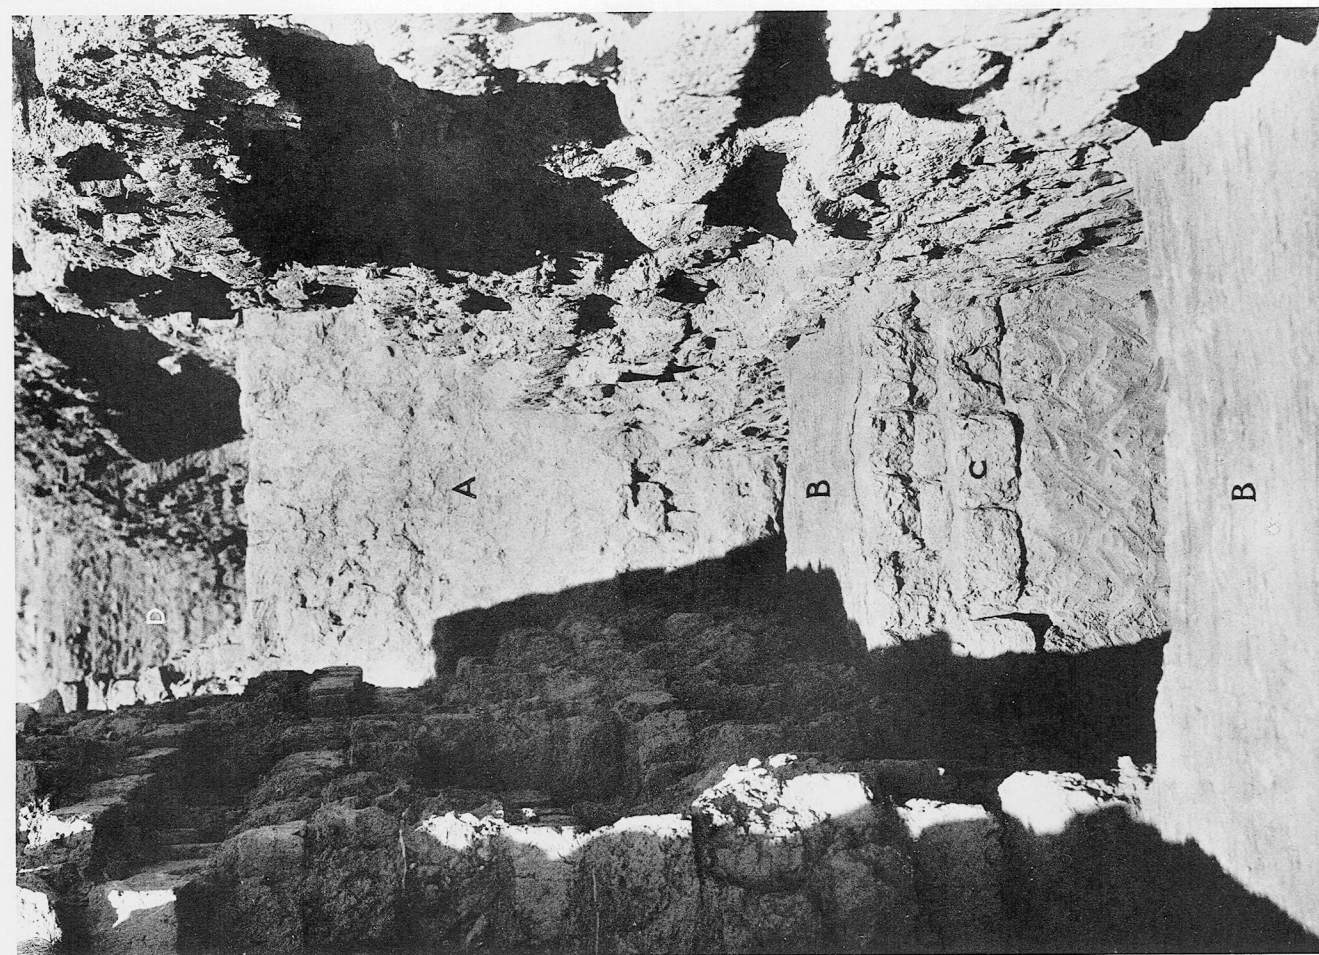
a. Ziggurat top, SE. side: cutting through Nabonidus' mud-brick terrace core showing: A, mud-brick third terrace of Ur-Nammu; B, layer of bitumen, reeds, and matting separating Nabonidus' mud-brickwork, from C, Ur-Nammu's mud-brick terrace floor-foundation. (See p. 112)

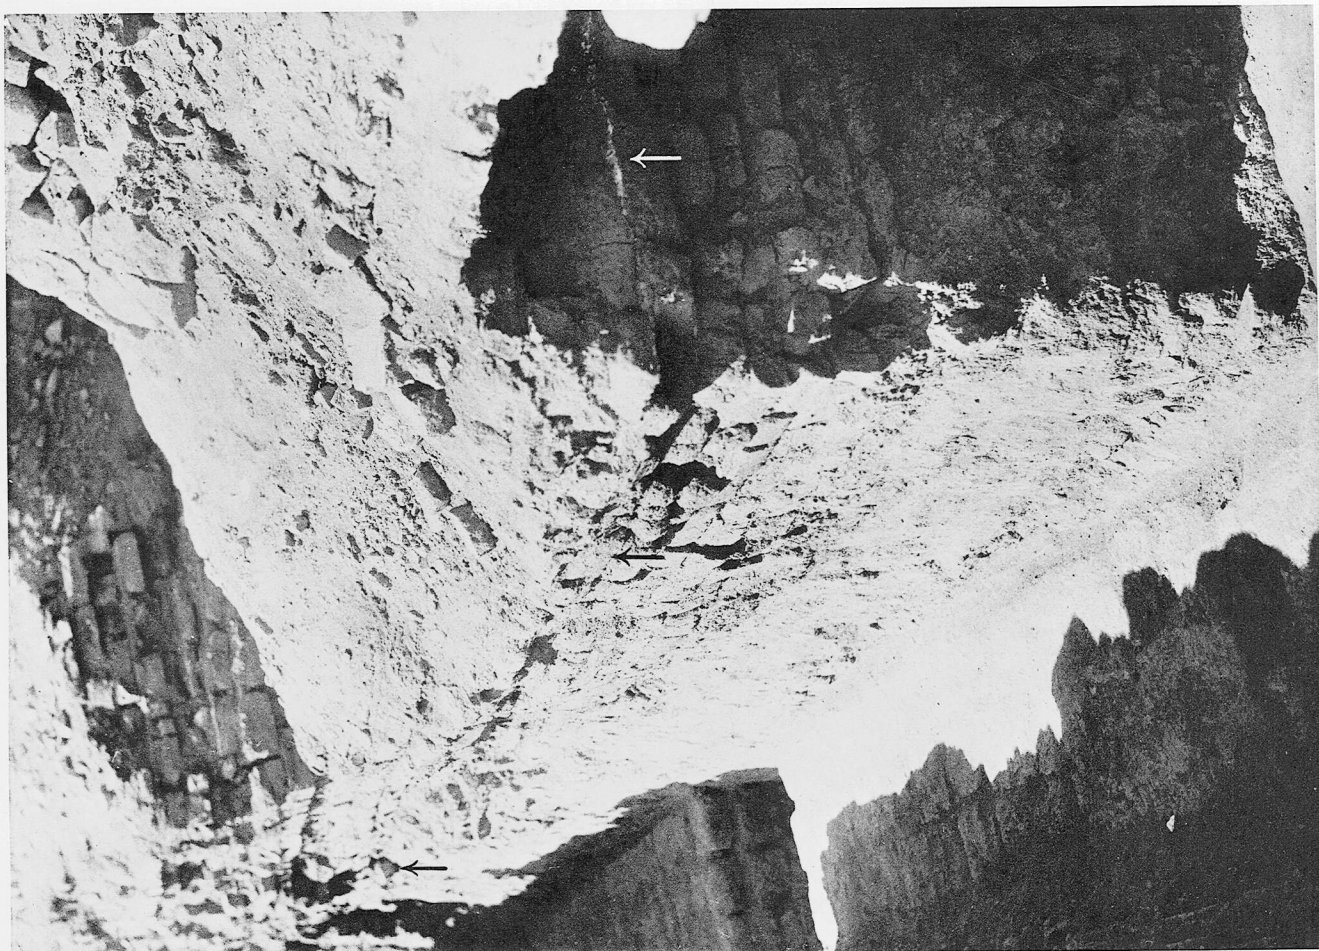
b. E. corner of the mud-brickwork of Ur-Nammu's third terrace; the exposed floor at the wall's foot is of Ur-Nammu mud bricks; above the arrow-points, the mud-brickwork of Nabonidus. (See p. 112)
